Root cause analysis of failure of 40th stage moving blade of single cylinder condensing turbine

Kumar R K*, Janardhana M* and Bhaskar Sharma K V**

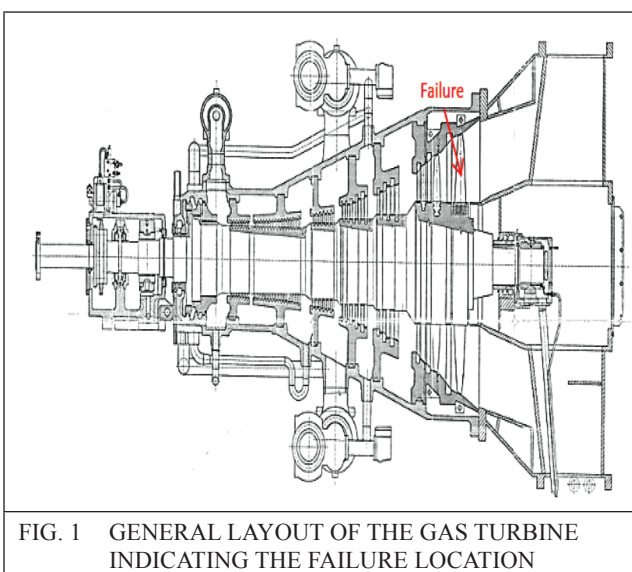
FIG. 1 GENERAL LAYOUT OF THE GAS TURBINE INDICATING THE FAILURE LOCATION

- It was found that the 36th blade of LP last stages were broken at the damping wire hole plane while in the 16th blade, long crack has been developed on inactive side. Both the blades are front and last blades in the packet

- Rubbing marks were observed on the casing in the direction of rotation.
- No damage marks were observed on the adjacent blades.

The location of the failure and the fractured condition of lacing wires observed is shown in Figures 1 and 2.

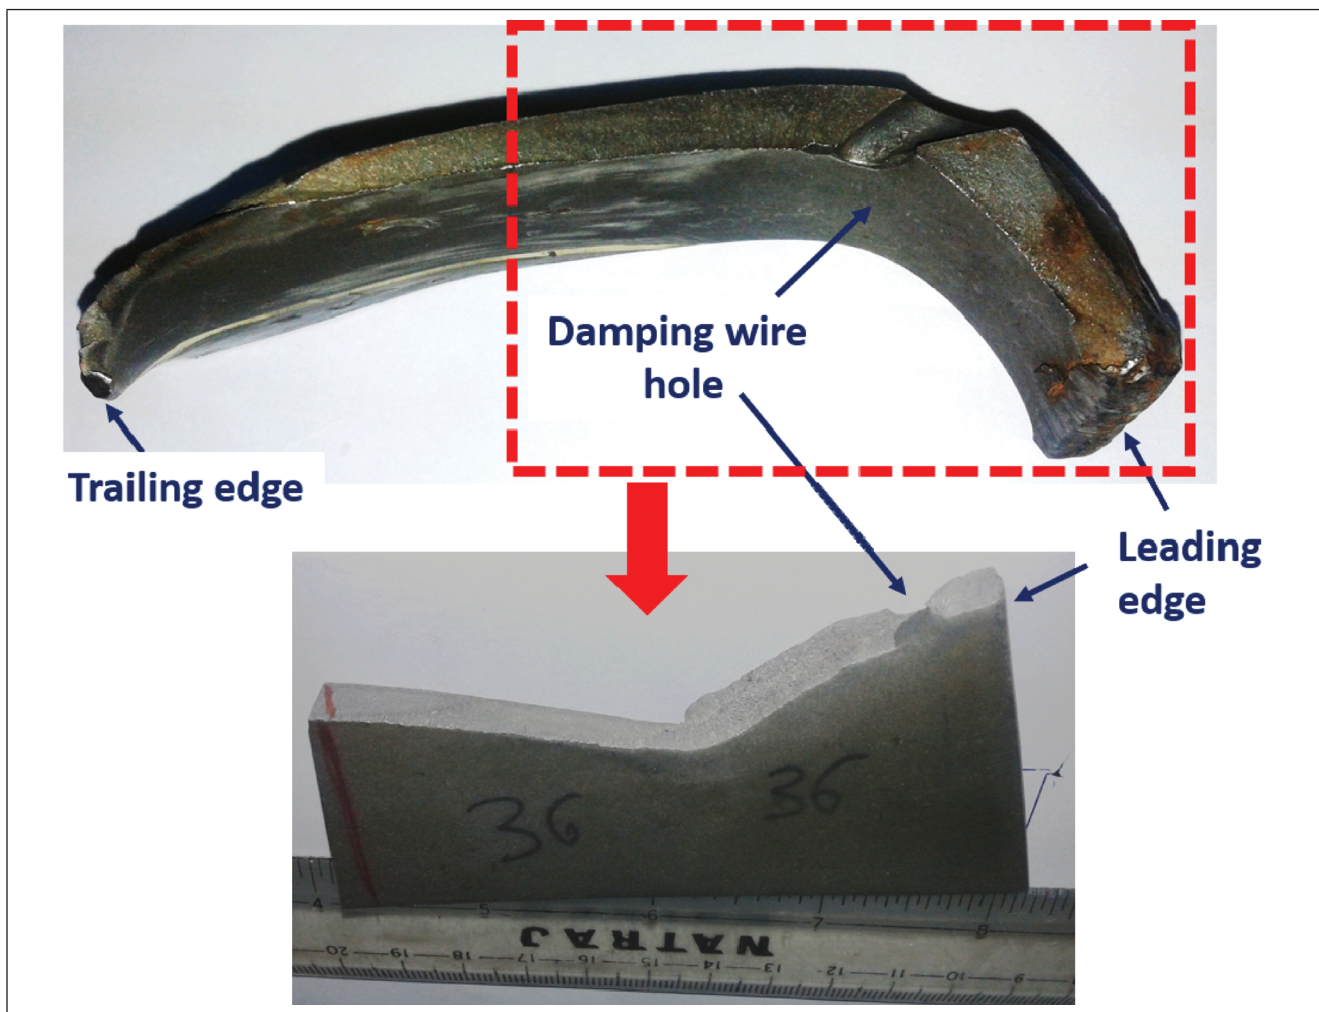
FIG. 3 FAILED BLADE 36 SHOWING THE FRACTURE SURFACE ON THE CROSS SECTION

The fractured blade (#36) had plastically deformed bend region close to the trailing end in the counter direction to blade rotation (suction side to the pressure side). The ID surface of the damping wire hole had shown localized rubbing/fretting marks close to the pressure side. In addition, ridges /steps like regions could be seen along the pressure side of the blade fracture surface.

The occurrence of these ridges is generally attributed to the torsional loading conditions of typical rotating components like a blade. In the present case, this is due to combined effect of possible steam hammering/fluttering of the blades and torsional loading. The suction side of fracture surface has shown typical of fine fracture indicating the final stages of the fracture process. The surface of the blade (along the blade length) did not show any abnormalities in the vicinity of the damping wire hole.

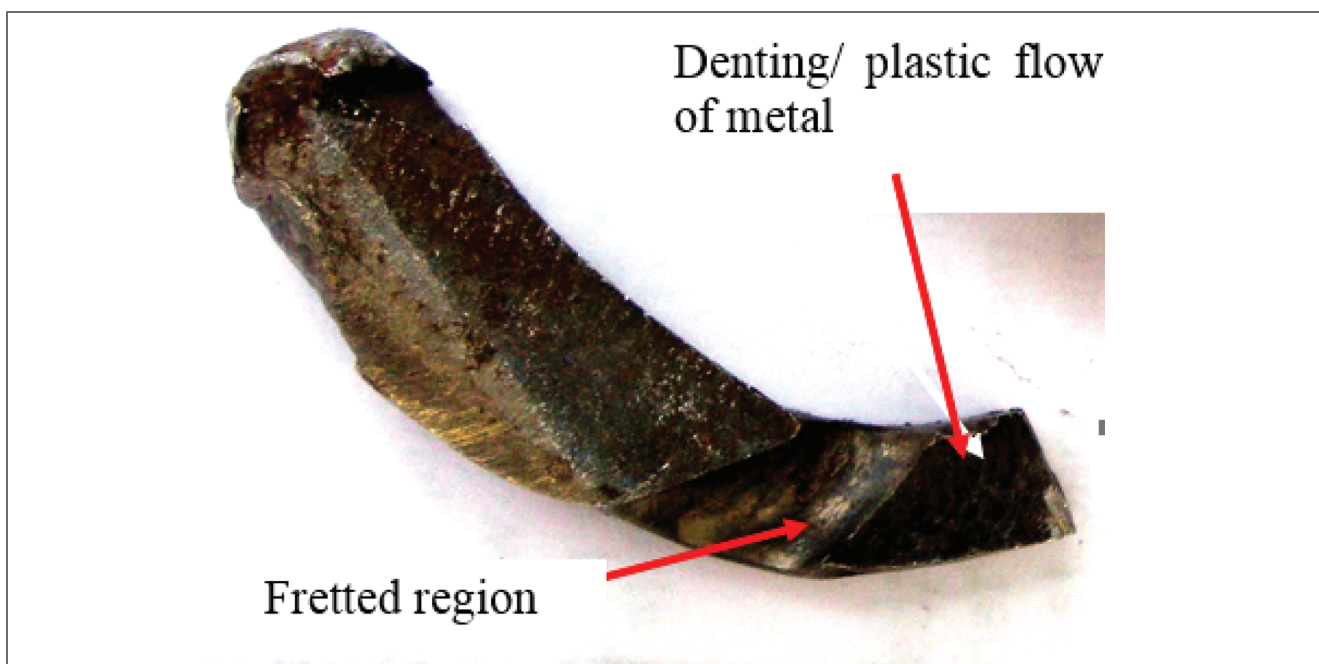
FIG. 4 VIEW OF FRETTED REGIONS OF DAMPING WIRE HOLE AND LOCALIZED DEFORMATION IN THE ADJASENT REGION

The fretting marks were observed on the ID side of the damping wire hole indicative of the fact that the blade was subjected to self-excitation.

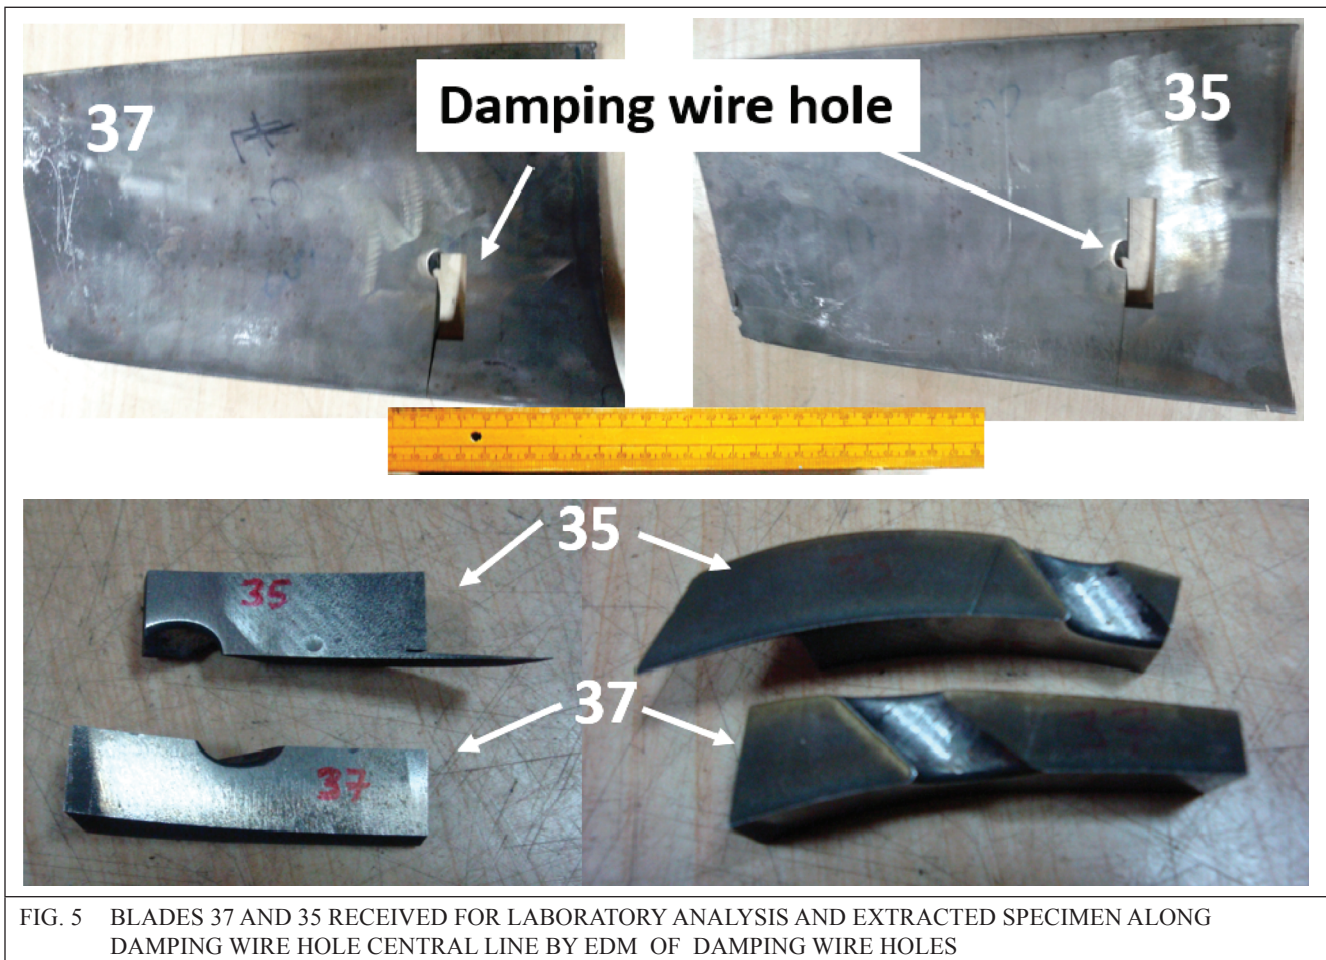
FIG. 5 BLADES 37 AND 35 RECEIVED FOR LABORATORY ANALYSIS AND EXTRACTED SPECIMEN ALONG DAMPING WIRE HOLE CENTRAL LINE BY EDM OF DAMPING WIRE HOLES

A small specimen of the blade around the damping wire hole has been cut by EDM on from both the blades 35, for assessment of the corrosion induced damages and the extracted specimen is shown in Figure 5. The EDM cut sample was subsequently cleaned in acetone ultrasonically. The complete region all along the bolt hole thickness directions have been analyzed through EDX. The EDX spectrum indicating various elements observed over different regions of the damping wire hole ID surface are shown in Figures 6 and 7.

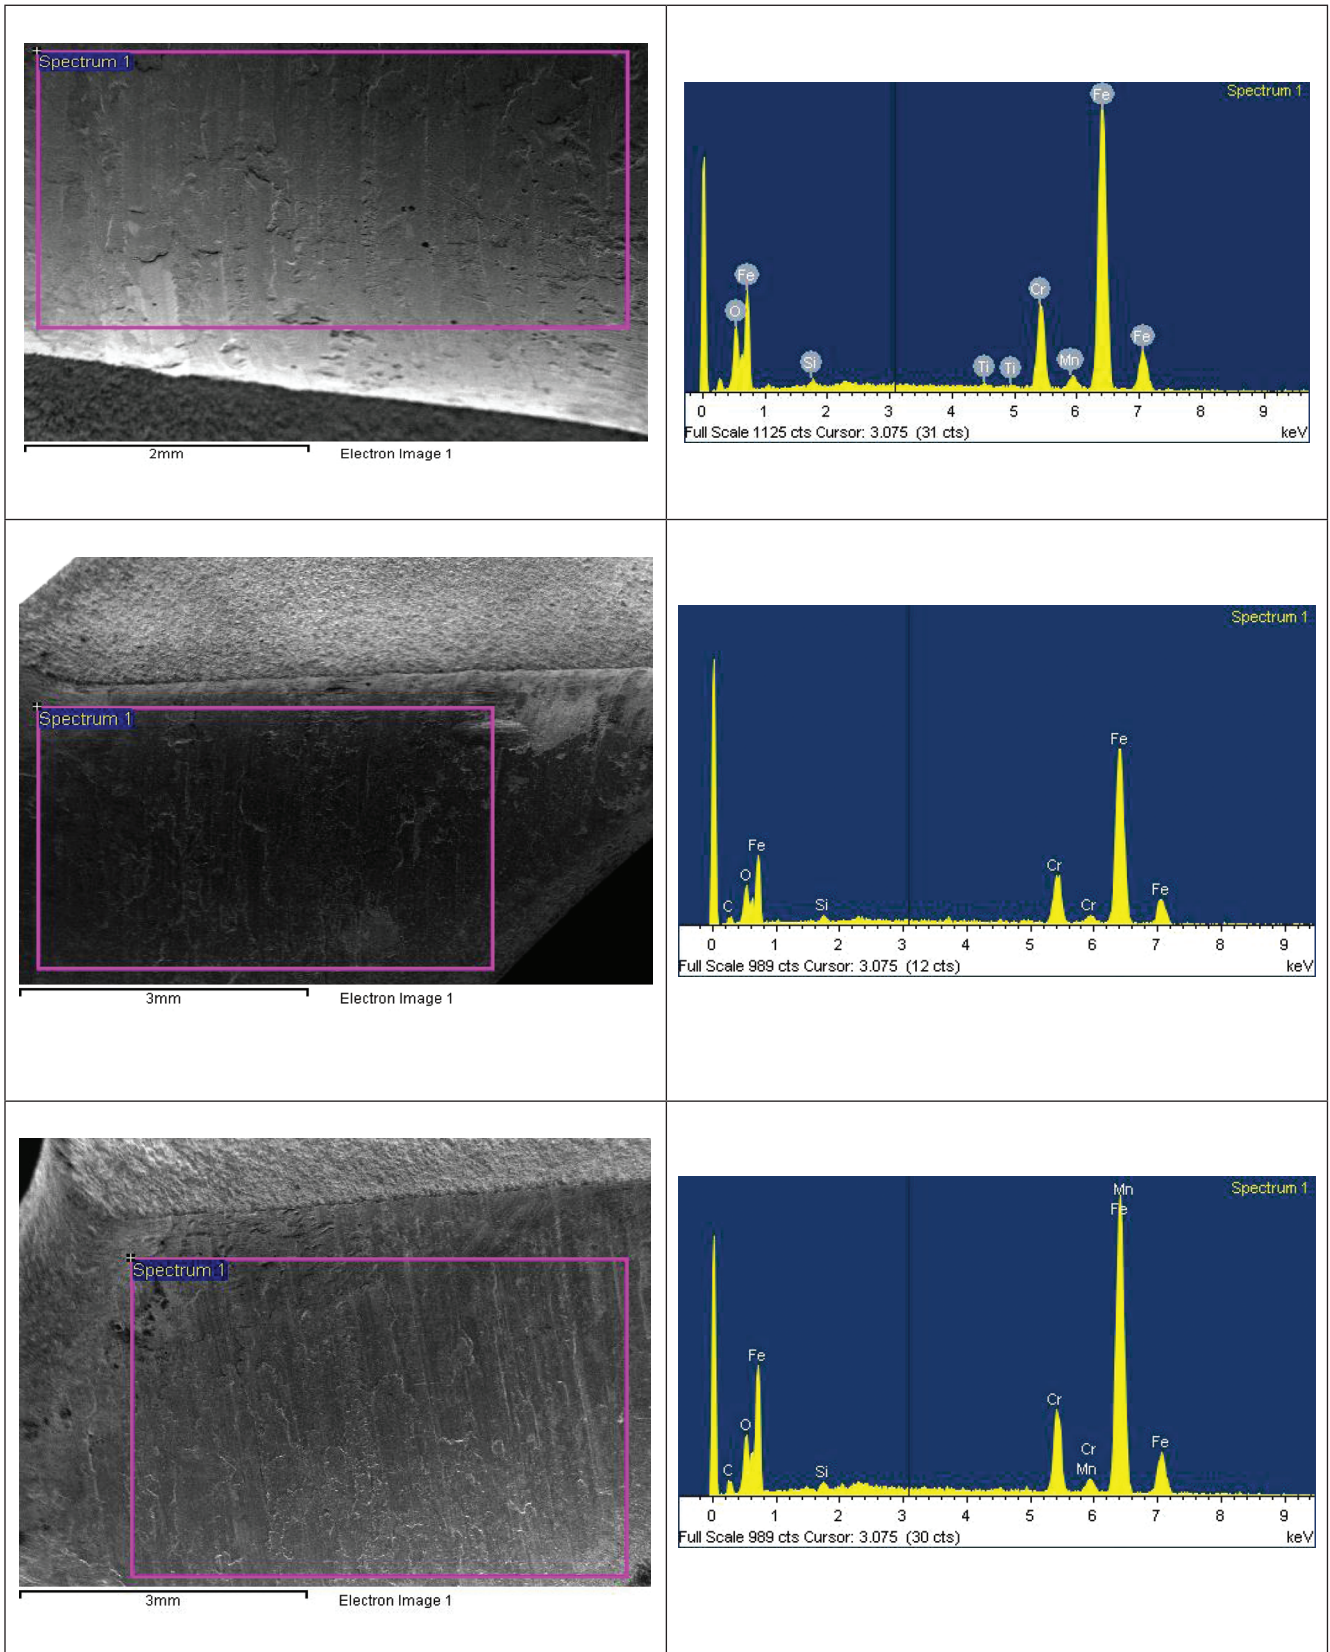
FIG. 6 ELEMENTAL MAPPING OF DAMPING WIRE ID HOLE SURFACES OF BLADE 35

The compositional analysis indicated that the ID surface consisted predominantly the oxides of iron

and titanium with alower amount of chromium, aluminum and silicon. Elements vanadium is observed in trace amounts in isolated regions. The observed titanium, aluminum and vanadium peaks are indicative of the fact that the titanium alloyed damping wire were effectively rubbing at the damping wire holes during the process of dampening of the blade vibrations.

The above analysis confirm that the prevalence of corrosion or cavitation on the ID surface of damping wire hole has not occurred.

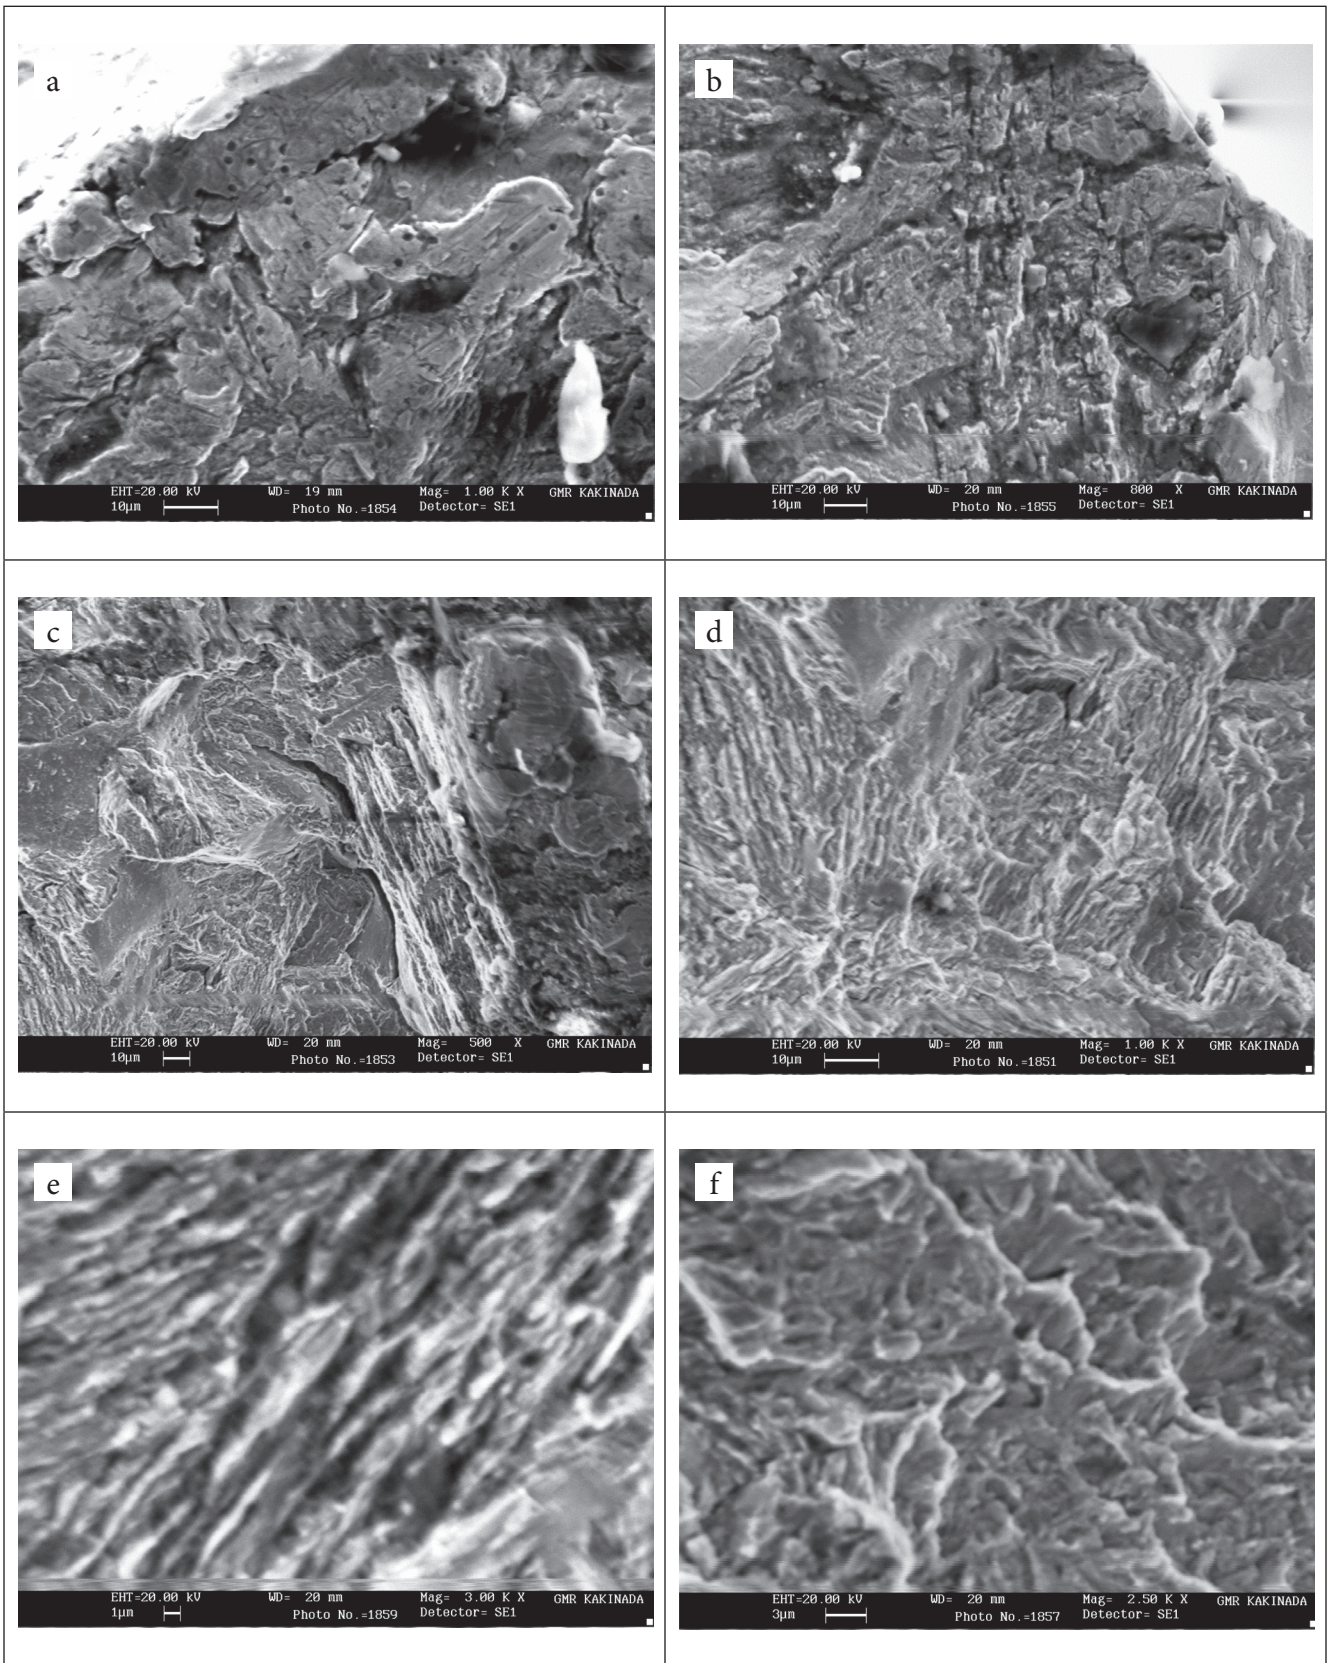
FIG. 8 FRACTOGRAPHY OF THE FAILED BLADE SAMPLE AT DIFFERENT REGIONS FROM THE DAMPING WIRE HOLE MINOR RADIUS

The fracture surface analysis of the cracked and failed blade in the region away from the damping wire hole and towards the tail end has been carried out. The view of the fractured blade received for analysis is shown in Figure 3 and the fractographs obtained close to the edge of the hole are shown in Figure 8. The fracture morphology lose to the damping wire hole has shown features of severe localized fracture of the metal (Figure 8a and 8b). The growth of striations in the adjacent regions could be seen in multiple directions (Figure 8c to 8e). As the hairline crack approached the pressure side of the blade, the final fracture has occurred with predominant and sudden ductile tearing (Figure 8f).

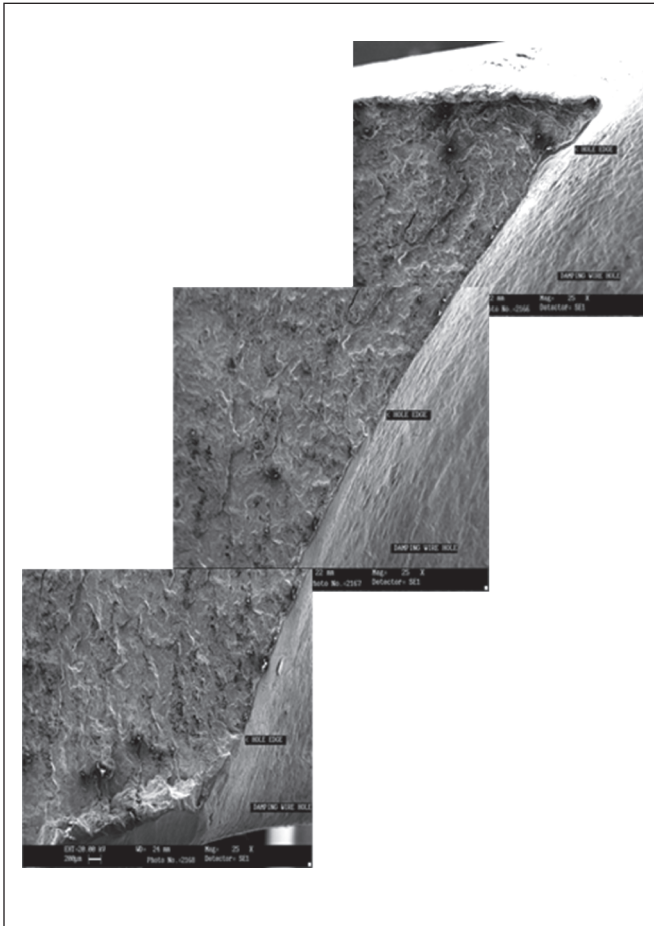
FIG. 9 STITCHED FRACTOGRAPH OF THE LACING WIRE HOLE EDGE -SIDE 1 (TOWARDS TRAILING END)

It has been observed that both sides of hole edges corresponding to the fracture plane have not indicated any ridges and other surface discontinuities. The localized mechanical damage (plastic flow/denting) at the end of the hole could be seen. The fracture region ahead of the local denting did not show the characteristic features of fatigue striations and hence this denting is attributable to possible secondary damage. The observed ratcheting marks on the suction side all along the length of the blade is indicative of the torsional loading of the blade prior to failure. The SEM analysis of the fracture region away from the hole edge has shown features typical of

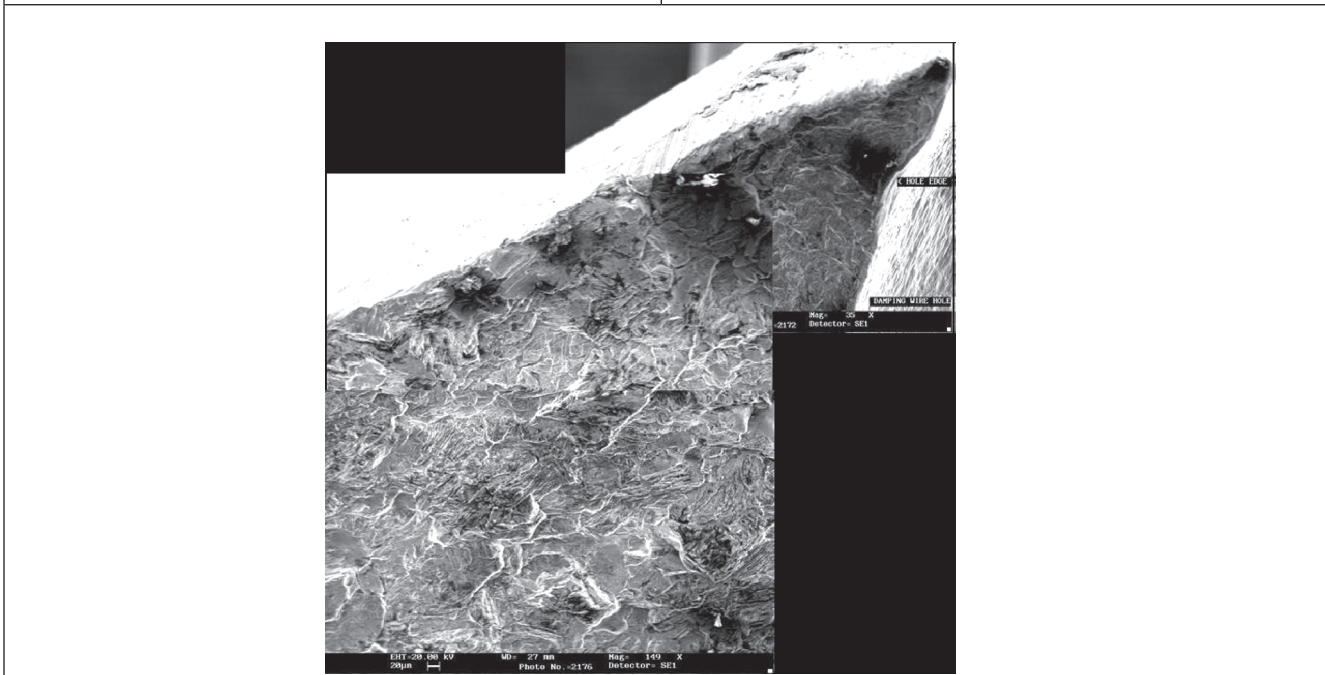
FIG. 11 FRACTURE MORPHOLOGY AWAY FROM THE DAMPING WIRE HOLE

mixed mode fracture viz. cleavage and ductile tearing regions along with striation like regions and cracking at isolated locations. The presence of cracks as observed in isolated locations on the fracture surface (Figure 12) is suggestive of the fact that the magnitude of stresses during the blade vibration during the continued service upon failure of lacing wire, is in excess of the yield strength of the material.

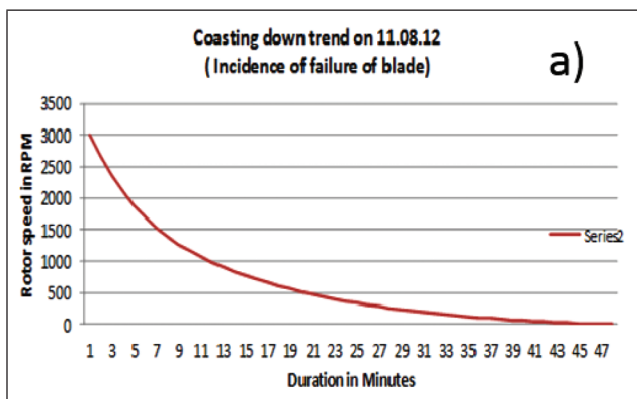
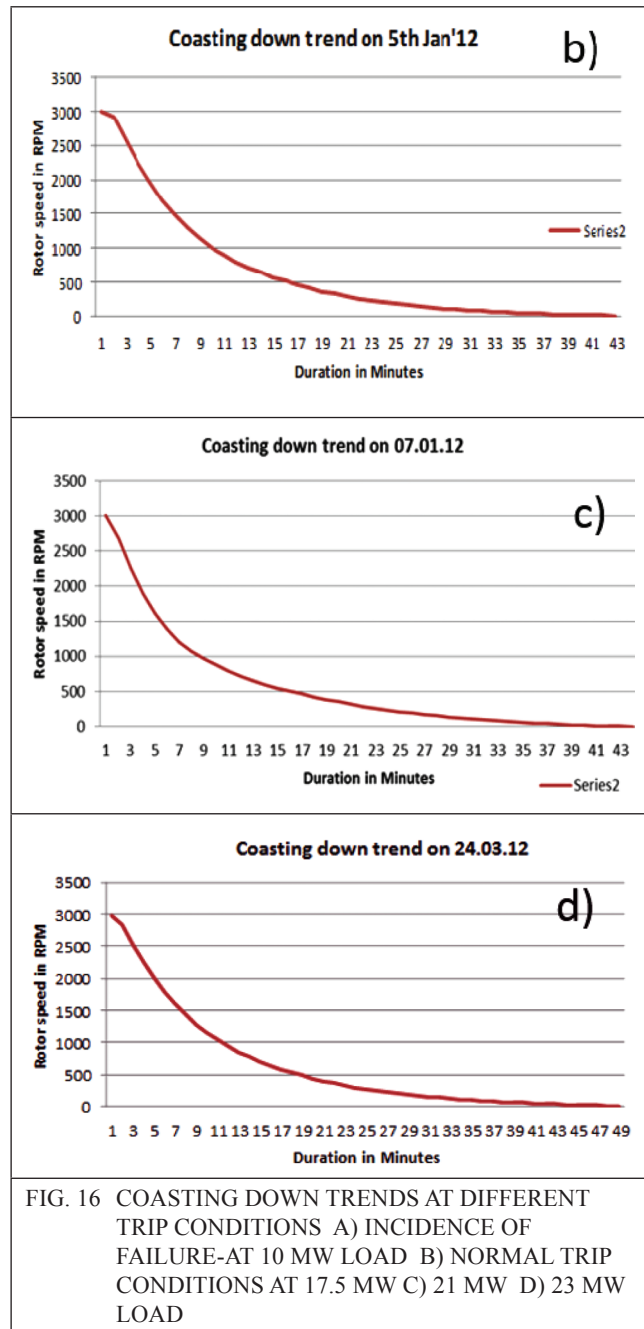
FIG. 16 COASTING DOWN TRENDS AT DIFFERENT TRIP CONDITIONS A) INCIDENCE OF FAILURE-AT 10 MW LOAD B) NORMAL TRIP CONDITIONS AT 17.5 MW C) 21 MW D) 23 MW LOAD

The coasting down signal at the time of failure incidence was compared with other tripping conditions and the analysis results are shown in Figures 13 to 16. With the alarm, the machine tripped on load and took 47 minutes to stop. The coasting down of the turbine is smooth and if any damage would have occurred earlier, coasting downtrend would have shown disturbances. The comparison of coast down plots indicate that there is no friction/rubbing effect until the machine came to near halt. All last stage blades of condensing turbines will have fundamental natural frequencies of coupled bending and torsion. Unless there is an unsteady flow, the blade cannot vibrate. The metallurgical observations indicate that the blade has atorsional sign of failure.

During normal tripping conditions at 17.5 MW, 21 MW, and 23 MW load conditions, the coasting downtime was recorded to be ~43 to 48 minutes. The increased coasting down time during the

blade failure load conditions of 10 MW, is mainly due to the fact that the machine got tripped under loading conditions (Figure 16a). The presence of a proportional quantity of steam present inside the turbine, in proportion to the load, provide additional inertia to the rotor.
