Failure analysis of high strength T91 boiler tubes used in thermal power plant: A case study

Arvind Kumar*, Malabika Roy*, Janardhana M* and Shekhar Kumar M*

A power generating utility of 600 MW has reported the failure of boiler tubes after a service life of 265 hours against the design life of 25-30 years. The failure of tubes was reported in Re-heater Inlet Coil tubes which were made up of high strength material alloy of SA 213 T91 grade. These boiler tubes were operating under a high temperature and pressure. The material used for re-heater and super-heater boiler tubes should have enough creep strength to sustain at high temperature and pressure. Even though T91 grade steel has superior quality of metallurgical properties in comparison to low alloy existing material like T11, T12 and T22, T91 tube was failed in a short duration. This paper describes the investigation of the failure of high strength T91 grade re-heater tubes in a coal fired thermal power plant. The failure investigation covers visual inspection, dimensional measurement, hardness mapping, oxide scale measurement, microstructural studies, and SEM and EDX analysis of the failed tubes. The analysis reveals that T

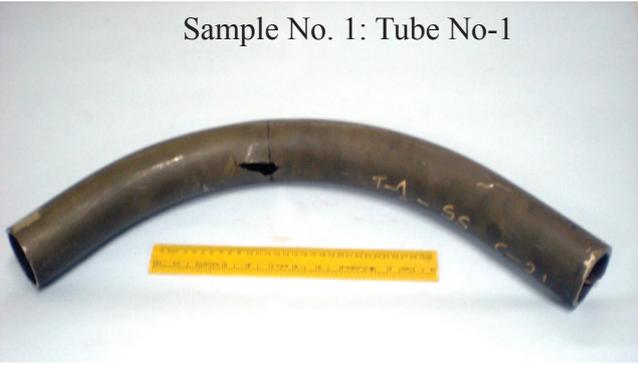
<p>Sample No. 1: Tube No-1</p>

- Tube No. - 1: An opening is observed near the bend section of the tube. The opening is at the opposite direction of the flue gas flow. Near the opening, steam erosion is also observed

on the tube surface. Neither swelling nor any scale/deposit was observed inside the tube. No other marks other than steam erosion patches were observed. Localized thinning is observed i.e. at the area of steam erosion section.

The boiler Tube No. 1, Tube No. 2 and Tube No. 6 are secondary failure due to steam erosion/impingement.

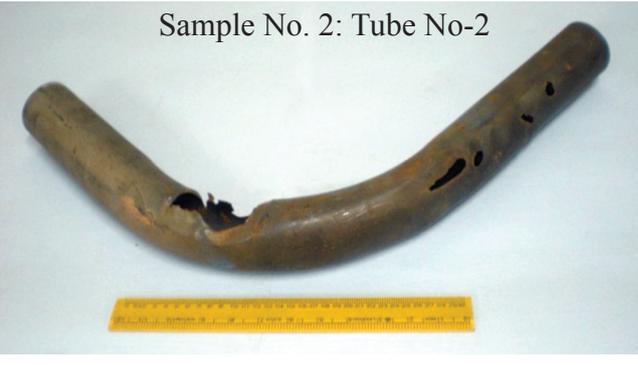
<p>Sample No. 2: Tube No-2</p>
<p>Opening near the bend section</p>	<p>Bull eye type & complete opening</p>

- Tube No. -2: A complete opening was observed near the bend section of the tube and bull eye type opening in other region. The failure section is in the 5 to 10 O' Clock position (flue gas direction is considered as 12 O' clock position). Steam erosion is observed in the failed region. Neither swelling nor any scale/deposit was observed inside the tube. Thinning observed only in the steam eroded section.

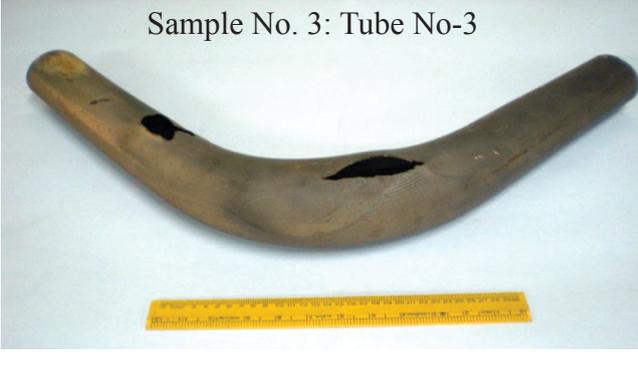
<p>Sample No. 3: Tube No-3</p>

- Tube No. -3: In this tube fish mouth opening and window type opening is observed. The window type opening is observed along 7 to 9 O 'Clock position which is observed due to steam erosion caused by other adjacent tube leakage. The fish mouth opening is observed near the bend section along the 8 to 10 O' clock position. Excessive amount of bulging is observed around this area. Stretch marks are observed near the failed section both from outside as well as from inside of the tube. The fracture surface shows thin lip knife edge. Neither scaling nor deposits were observed from inside of the failed tube.

The visual observations for all the four samples revealed large opening. Longitudinal wall thinning was observed in the Sample Tube No-3 along the fish mouth opening. Stretch marks (thermally deteriorated) are also observed around the region of fish mouth opening. The fracture surface of the fish mouth opening shows thin lip with knife edged. The surface shows little ductility in nature that may be due to short time exposure of high temperature effect and the surface got oxidized. There are no abrupt changes in the microstructure of the tubes sample taken from sample tube no- 1, 2 and 6 i.e. secondary damaged tubes. While the microstructure of the tubes samples taken from different region from fish mouth opening Sample tube no-3 shows more amount of austenite phase and precipitated carbide in-comparison to sample taken from away of the fish mouth opening. The

In tube No. 3, neither any deposit nor any oxide scale was observed inside the tube. The bulging with stretch mark was observed in the localised area of fish mouth opening region. The

microstructure of the sample taken from the tip of fish mouth opening shows more percentage of carbide precipitation. The increasing percentage of carbide precipitation in the localised region indicates for overheating for a short duration of time. From the analysis it is concluded that the tube has failed due to short term overheating [1, 3, 7]. The short term overheating may be due to any one or combination of the factors like, loss of enough coolant circulation, uneven firing of fuel burner, and large fluctuation in load swing or change in firing pattern.

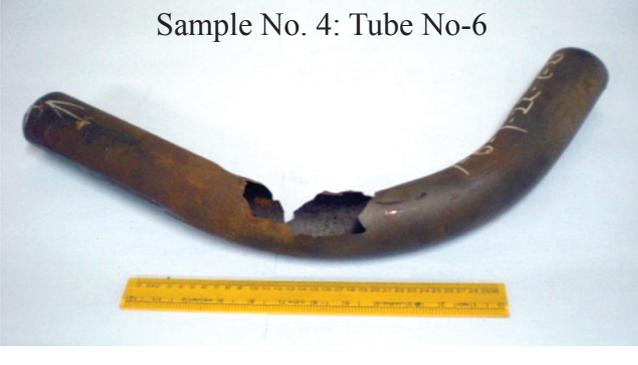
<p>Sample No. 4: Tube No-6</p>
<p>Fish mouth & window type opening</p>	<p>Bull eye type & complete opening</p>
<p>FIG. 1 FAILED BOILER TUBES (AS RECEIVED)</p>

- Tube No. -6: A bull eye type and complete opening is observed on the tube surface. The failed section is observed along 6 to 11 O' Clock position. Steam erosion patches are observed along the failed section. Neither swelling nor any scale/deposit was observed inside the tube. Thinning is observed only in the steam eroded section.

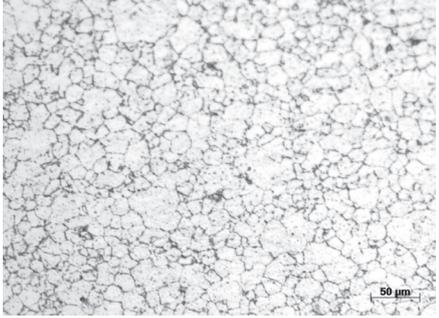
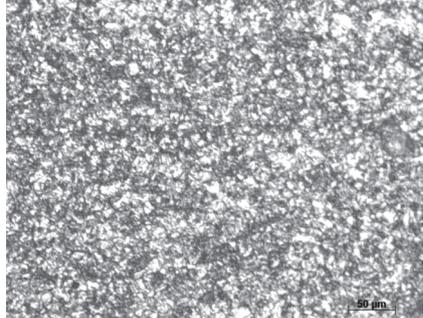
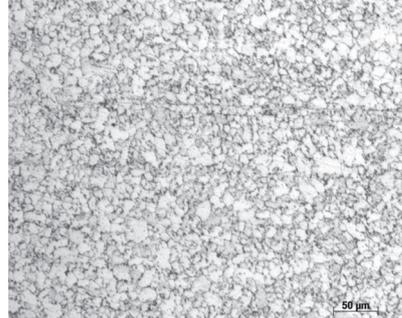
Since there are no changes in the microstructure for the samples taken from tubes 1, 2 & 6, it indicates that these tubes have failed due to steam impingement. The failures modes of the tubes 1, 2 and 6 are secondary damaged.

<p>Tube No- 1, 200X Sample taken from erosion failed section: The structure shows normal austenitic phase.</p>	<p>Tube No- 2, 200X Sample taken from erosion failed section: The structure shows normal ferrite tempered martensite.</p>	<p>Tube No- 6, 200X Sample taken from erosion failed section: The structure shows normal ferrite and pearlite</p>
<p>FIG. 2 MICROSTRUCTURE OF THE SAMPLES TAKEN FROM FAILED TUBES 1, 2 & 6</p>

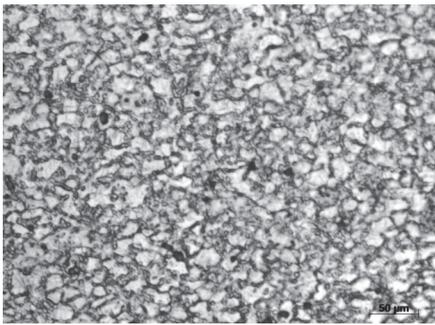
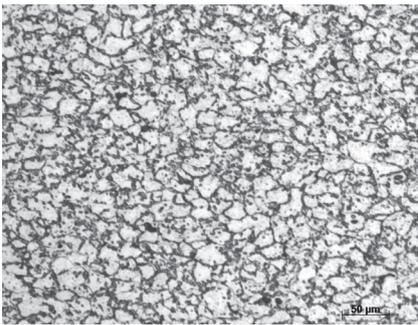
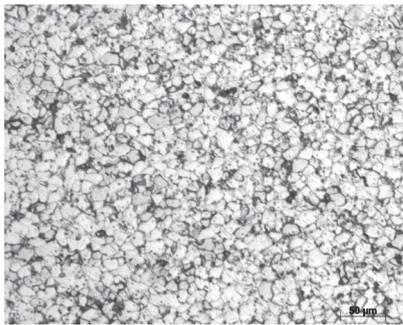
Samples were also taken from the different section of primary failed tube (Tube No-3) i.e from the tip of fish mouth opening and away from the failed section for the microstructural analysis as shown in Figure 4. The microstructures of sample taken from the tip of fish mouth opening region showed relatively more carbide precipitation compared to sampling taken away from the fish mouth opening.

<p>Sample taken away from the fish mouth opening section: The structure shows minor in-situ precipitation of carbide along grain boundary.</p>	<p>Sample taken from another location of fish mouth opening section: The structure shows precipitated carbide along grain boundary.</p>	<p>Sample taken from tip of the fish mouth opening section: The structure shows precipitation of carbide along grain boundary and creep void formation</p>
<p>FIG. 3 MICROSTRUCTURE OF SAMPLES TAKEN FROM FAILED TUBE NO 3 (200X)</p>

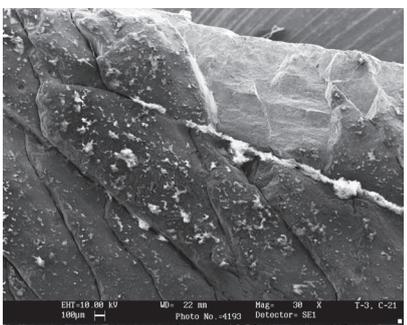
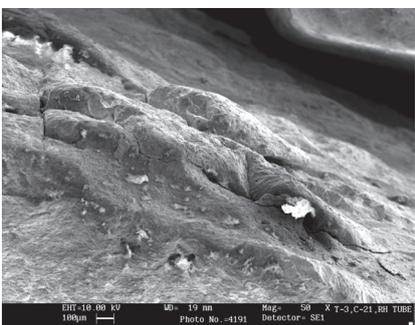
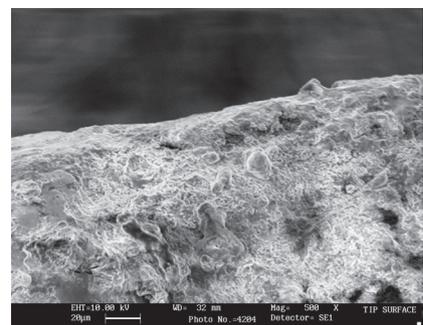
FIG. 5 SEM PHOTOGRAPH

The SEM photograph in Figure 5 shows the many crack lines and the fly ash particles on the tube metal surface and in between the stretched lines. The SEM photograph shows the material has got little ductile failure before opening indicating the high temperature effect for short time of period. The same sample was analysed through EDX and the results are shown in Figure 6. The spectrum taken from the metal surface shows more percentage of iron oxide (more than 70%) and less alumina and silica while the spectrum taken from the slag region shows more percentage of alumina and silica (around 95%) and no iron oxide in the case of flue dust particle.

<p>Sample taken from stretch marked region showing crack lines with fly ash particles.</p>	<p>Sample taken from tip of fish mouth opening showing less ductility</p>

increasing percentage of carbides indicates that the tube has experienced overheating for a short period of time. The SEM results of the fracture surface shows many cracks line in the region of stretch marks, the fractograph surface show little ductility in nature. The less ductility observed on the fracture surface indicates for overheating for shorter time of period.
