Failure of Short - Circuit Generators: A Case Study by CPRI, Bhopal

Arun Kumar Datta*, Ansari M A*, Mondal N R* and Raghavaiah B V*

Year 2006–2007 was a test time for CPRI, Bhopal, when both the short-circuit generators have developed technical snag, resulting in an interruption of short-circuit testing. It was a challenge for CPRI as well as for the service provider to take repair work, as so many technical intricacies were involved including the reverse engineering process. Nation realized the importance of CPRI during the shutdown period. This paper discusses about the occurrence of failure, its detailed diagnosis, root cause analysis and the action taken thereafter. Short-circuit generator is different from conventional one in many aspects. Repairing experiences of these generators, along with the re-commissioning process, are also shared herewith.

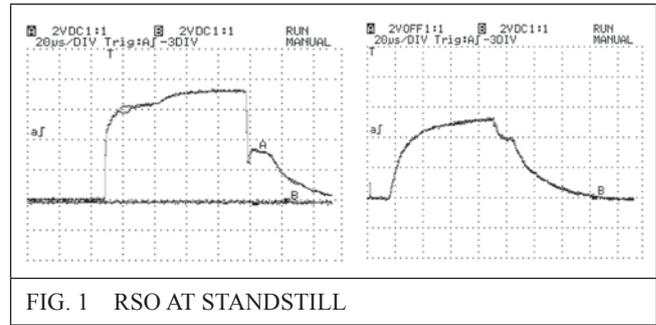
FIG. 1 RSO AT STANDSTILL

RSO test did not show (Figure 1) much deviation in wave shapes in the transmitted and reflected waves.

IR value and rotor impedance (at 50 Hz) were measured. All the test results were showing normal values at standstill condition. Hence, it was decided to conduct further investigations in running condition.

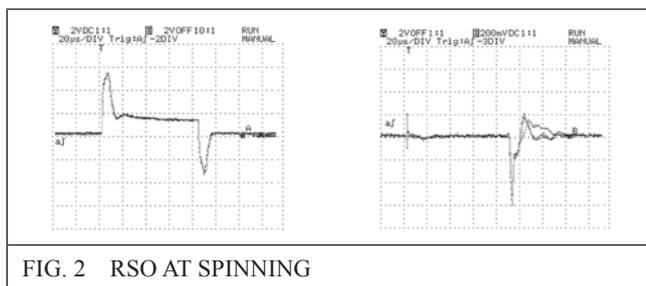
FIG. 2 RSO AT SPINNING

RSO at spinning showed (Figure 2) abnormality in rotor circuit at speed above 2000 rpm and that indicated earth fault or zero IR value between rotor winding and shaft.

Hence, it was concluded that the rotor was having flying earth fault, and also higher field current indicated inter-turn short during running at rated speed. Rotor was threaded out from the stator bore and for further action, it was sent to the works of the service provider.

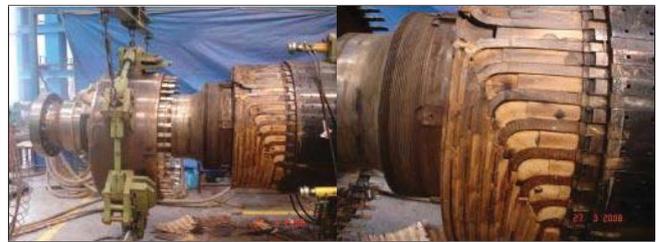
FIG. 3 DISASSEMBLY OF ROTOR

Retaining rings were removed from the machine (Figure 3). Complete disassembling of rotor was carried out. Rotor disassembling included dismantling of slip rings, CC bolts and D leads. Rotor coils were of continuous type.

A few slot wedges had shown hair-line cracks of about 10 mm length during DP test. Wedges (both ends) were strengthened with brazing alloy as a preventive action for future. Rotor body was sand-blasted and thereafter, insulating paint was applied on it.

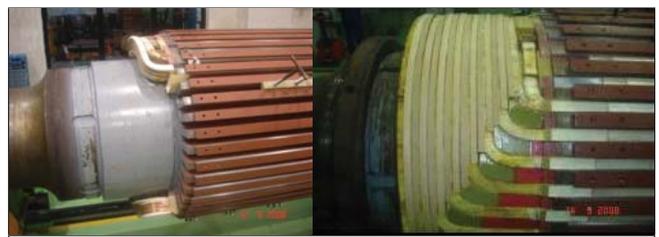
FIG. 4 PROCESS OF ROTOR REPAIRING

The flying earth fault of this rotor was a typical condition which could not be pin-pointed accurately at standstill condition. This machine was more than 45 years old with class ‘B’ insulation, which got deteriorated over the years. A complete rewind with upgraded insulation was the only complete proof method of addressing the problem. Any other patch work would have involved high degrees of risk.

Rotor rewinding (Figure 4) was done using same copper with new class ‘F’ imported insulation.

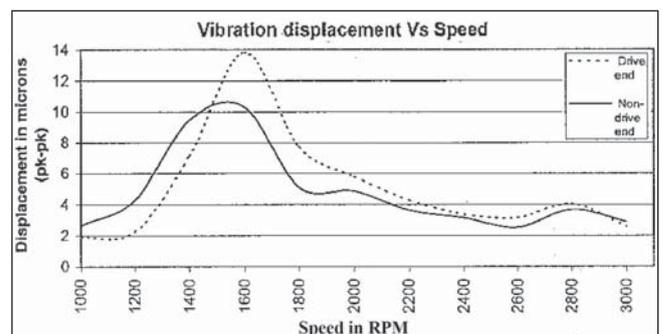
FIG. 5 VIBRATION DURING BALANCING

- Over speed test at 10 % above nominal speed was carried for 2 minutes [1].
- Rotor balancing was done at 3000 rpm and vibration values (Figure 5) were taken.

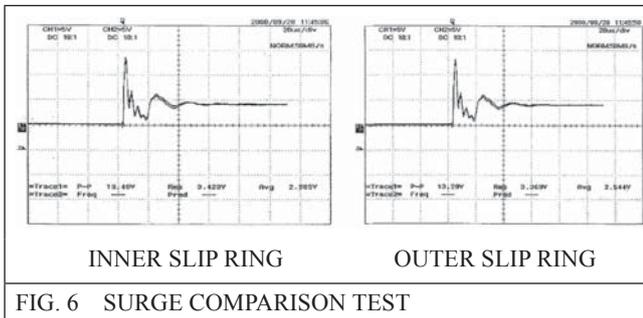
FIG. 6 SURGE COMPARISON TEST

- Surge comparison tests were performed during and after balancing (Figure 6).

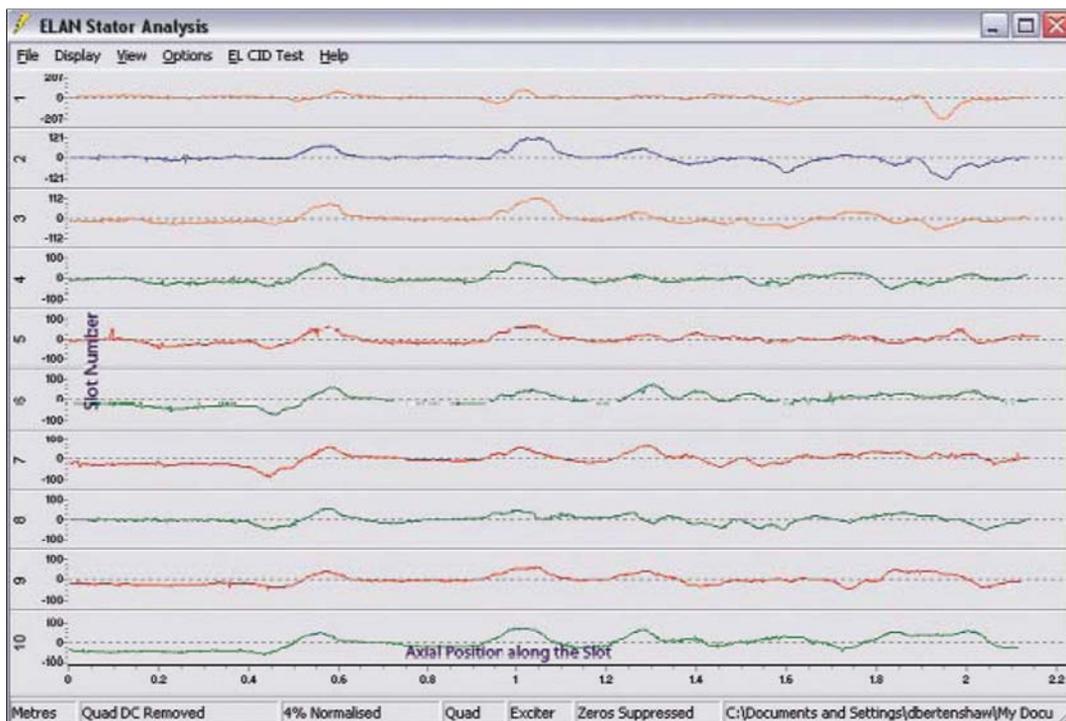
FIG. 7 ELCID TEST

This test is carried out on the stator winding of generator to detect imperfections, faults and hot spots in the stator core. Core laminations are coated with a thin layer of electrical insulation to prevent eddy currents being induced between them by rotating magnetic field. ELCID test was conducted by passing an exciting current of 13.45 Amps through six turns of looped wire around the stator frame. Test results showed that inter-laminar insulation of the stator core is healthy (Figure 7).

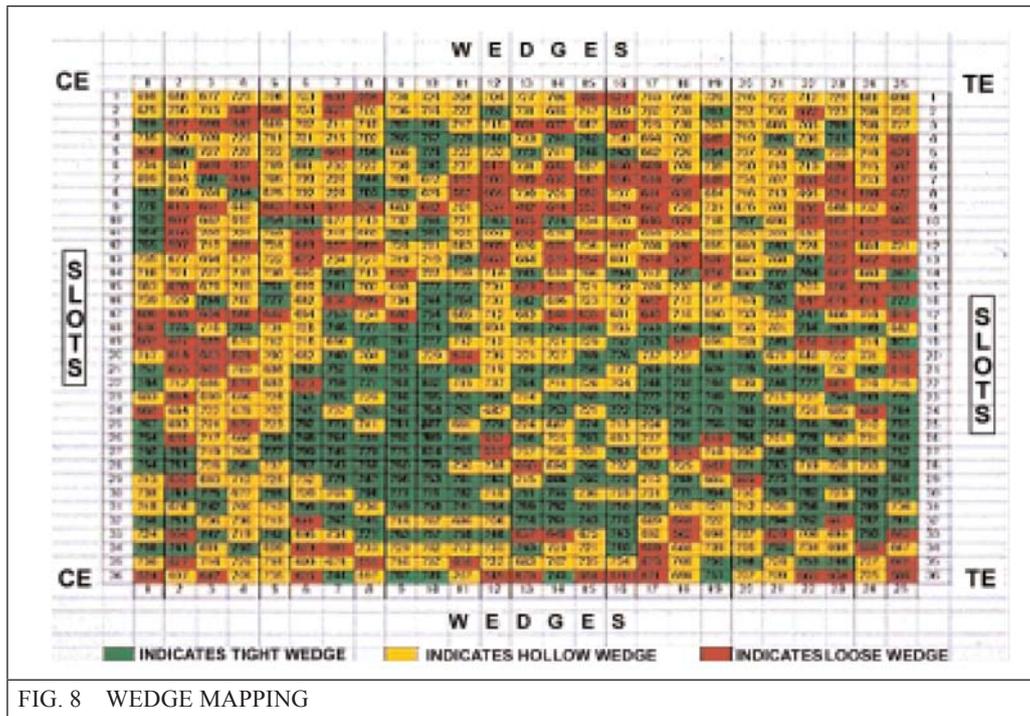
Wedge mapping test (Figure 8) revealed that about 19.5 % of the wedges were loose and about 19.6 % of the wedges were slightly loose. Hence, according to the recommendation, re-wedging of the stator winding was carried out.

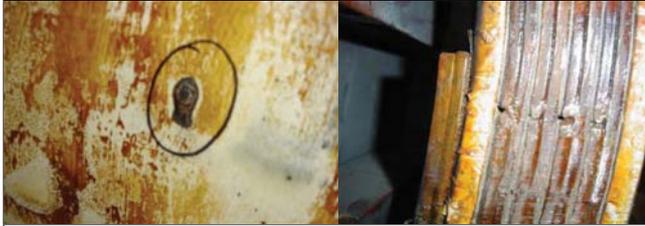
FIG. 10 INSULATION FAILURE AND CREATION OF VOID

of retaining rings, it was noticed that the melted copper had pierced the insulation under the retaining ring (Figure 10). When the insulation sheet was removed, voids were observed on a few coils and between the copper strands at the brazed junction.

The failure occurred after 1500 starts, and consequently 1500 heat cycles. It was supposed that the cracks occurred due to a mechanical fatigue inside the copper strands at the brazed junction level. The voids at the brazed junction made stress concentration (Figure 11) in those areas. That was the most probable aggravating factor. The brazing of the copper made the copper material softer and consequently reduced the fatigue limit of the junction. This rotor was manufactured at England. The brazing material

contained phosphorus. The brazing material was used due to safety rules in England [2]. A lot of cracks were found mainly on the brazing between the coil-to-coil connection pieces and the copper strands.

- Opening of the turn at the brazed junction level.
- When the conducting surface was too small, some copper strands melted.
- Some short circuit occurred between the turns which had melted copper stands.
- The melted copper flew towards the outer diameter and pierced the insulation under the retaining ring.
- DP test was performed on the retaining rings. No crack was discovered. They are not damaged by the electric flash because the earth fault was made with the dampers.

- Disassembled the complete rotor.
- Replaced the copper strands which were submitted to high stresses.
- Suppressed the stress concentration by filling all the voids between the copper strands at the brazed junction level with new brazing material.
- The rotor was rewound (Figure 12) with new Class F insulation (slot liners and the top packers).

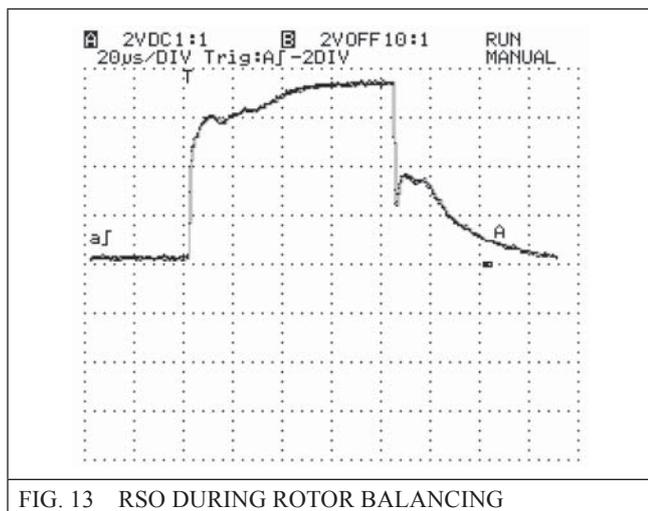
FIG. 13 RSO DURING ROTOR BALANCING

- After assembling all pressing tools, rotor coil insulation polymerization cycle was performed at 100°C.
- Over speed at 10 % above nominal speed was carried for two minutes [3].
- Rotor was balanced at 3000 rpm and vibration values were NDE: 7.067 microns (pk-pk) and DE: 5.115 microns (pk-pk).
- During balancing, RSO test was performed (Figure 13) in running condition at nominal speed.
- IR value, winding resistance and high-voltage test results are tabulated below (Table 7).

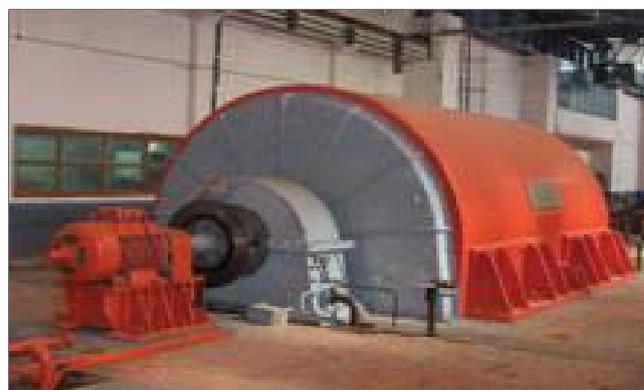
FIG. 14 RE-ASSEMBLED GENERATOR AND OCC THEREAFTER

Re-commissioning work (Figure 14) was carried out, and OCC was also plotted (Figure 15), which was identical to the earlier characteristics.
