## Assessment of Stator Winding Insulation

### Part 2 – Tests on Inservice Machines

Nageshwar Rao B\*, Mallikarjunappa K\*, Keri C D\*, Afzal Ahamed T R\*,  
Sudhindra A\* and Ramachandra B\*\*

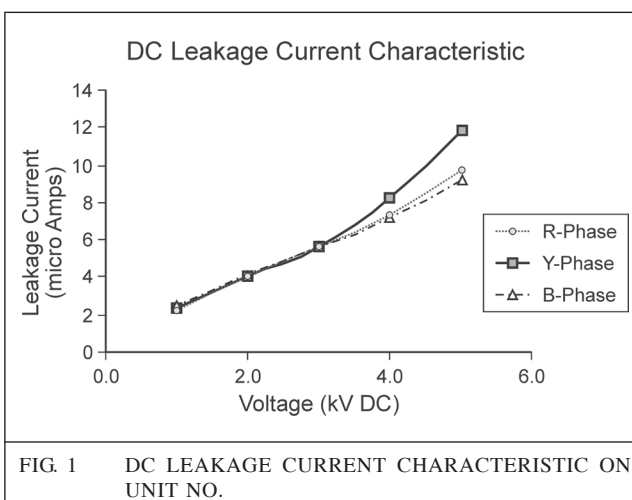
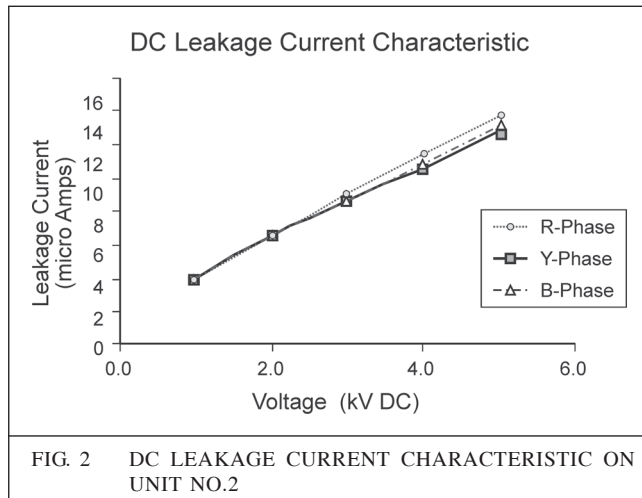
The IR and PI values of units 1 and 2 lie in the acceptable range for a 51 years old machine indicating that the stator winding is clean and dry. The DC leakage current characteristics obtained on the stator winding showed the magnitude of the leakage current was small and its variation with the test voltage does not exhibit steep slope as shown in the Figs. 1 and 2. These results further confirm that surface conditions of the stator winding are dry.

Based on the above findings it was recommended that insulation condition is quite healthy and to repeat the tests after two years to monitor the trend in ageing as it is an ongoing process.
