## A case study of high temperature reheater boiler tube failure

Arvind Kumar\*

A failure was reported in reheater tube of 210 MW thermal power station after serving a period of 1,65,900 hrs. At the time of failure, the reported parameter like temperature was 540<sup>o</sup>C and pressure was 35- 40 Kg/cm<sup>2</sup> and the grade of the material was SA213 T22.

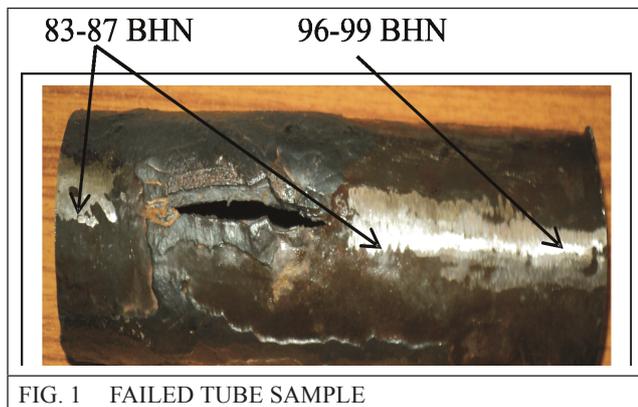
Hardness measurement was carried out at different location of the reheater tube as shown in Figure 1 by using portable Hardness tester (Equotip2™ make- Switzerland), along the transverse direction of failed section, and the hardness value is found to be 96- 99 BHN at 10 inch away from the failed section while at the failed section hardness value was found 83-87 BHN. At 180° opposite of the failed section, the hardness values were found in the range of 102-108 BHN, which are given in Table 2

TABLE-2		
BRINELL HARDNESS NUMBER (BHN) OF FAILED TUBE AT DIFFERENT LOCATION		
Near the failed section	Away (5 inch) from failed section	Opposite (180°) of the failed section
83-87	96-99	102-108

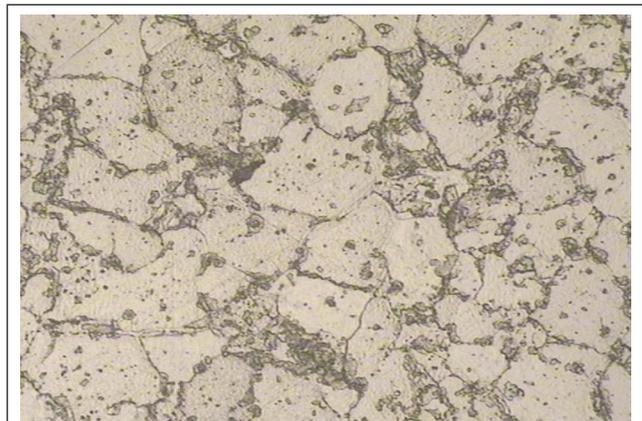
FIG. 2 50 X, MICROSTRUCTURE OF SAMPLE TAKEN FROM TIP OF FAILED SECTION.

The microstructure of the sample taken from the tip of failed section of reheater tube shows ferrite with precipitated carbide, the pearlite has been fully decomposed. The precipitation of carbide is due to long term overheating [1, 12-13]. Oxide scale thickness was measured in the microscope and the values were found in the range of 1000 micron along the failed section as shown in Figure 3.

The microstructure reveals ferrite and accumulation of precipitated carbide throughout the matrix. The structure also shows that the tube has undergone high temperature oxidation. Due to precipitation and accumulation of carbide the strength of the material has deteriorated. The microstructure analysis of oxide layer indicated

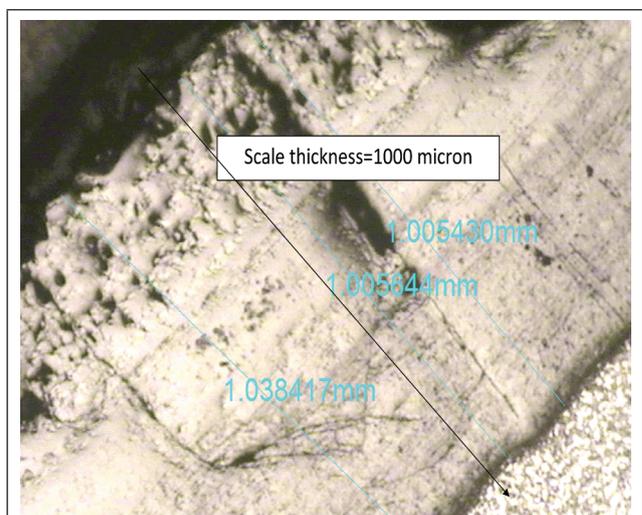
FIG. 3 50X, OXIDE SCALE AT THE INNER SURFACE, THE SAMPLE TAKEN NEAR FAILED SECTION.

that the layer is formed at the expense of tube wall. Thus by oxide scale deposition the tube suffered thinning by oxide conversion of wall metal. The microstructure analysis also reveals different layers of oxide scale deposition and presence of voids in the tube wall. Due to oxide scale deposition inside the tube, it acts as thermal barrier for heat transfer thus increasing metal temperature and making the tube softer by decreasing the strength. The effective metal wall temperature calculated for the oxide layer of 1000 micron was 607° C, which is much higher than the safe operating temperature of the material is due to higher temperature, and hence the microstructural and mechanical property got degraded [11].

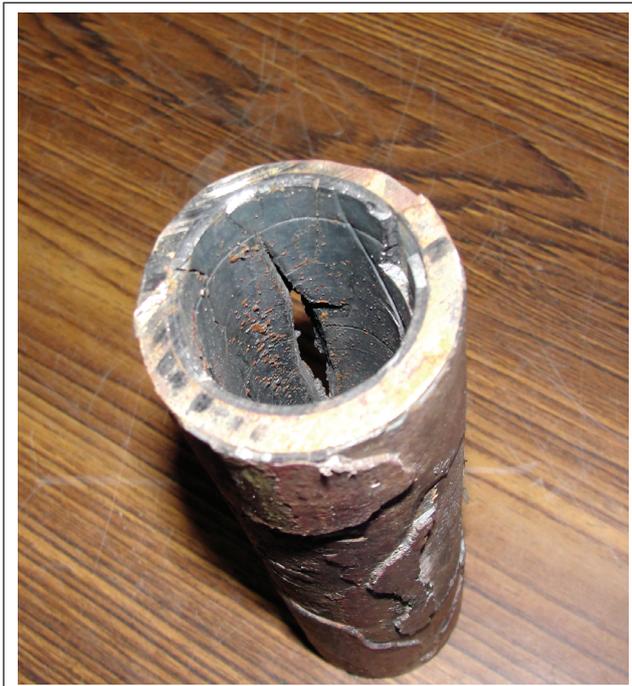
Figure 4 showed scale deposition on inside and outside surface of the failed tube. Inside oxide scale was measured by the thickness instrument 37 DL plus (Olympus make) on the failed tube at different location.

FIG. 4 INSIDE AND OUTSIDE SCALE ON THE FAILED TUBE

Oxide scale was measured at different position on the failed tube sample; the oxide scale measured was in the range of 800 to 1100 micron along the failed section i.e., 12 O' Clock position while it was in the range of 500 to 800 micron at 180 degree opposite of the failed section.

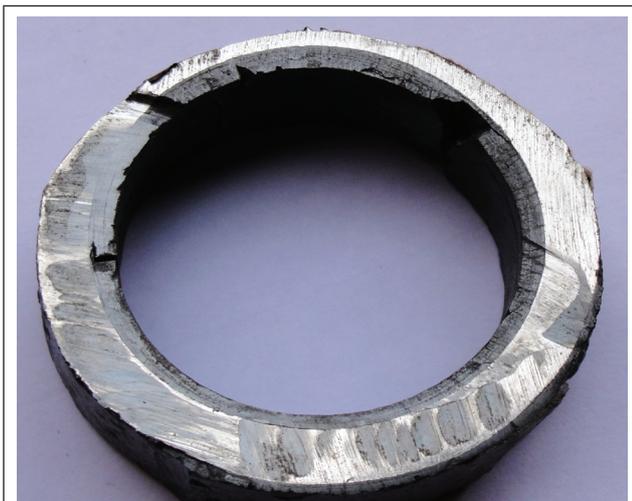
FIG. 5 INSIDE AND OUTSIDE SCALE ON THE FAILED TUBE

The Figure 5 shows the cross-sectional view of the failed tube showing non-uniform scaling on the inner side of the tube.

Figure 6 to 8 showed the schematic growth of inside oxide scale deposition along the cross-sectional area with different running time of the plant. Initially, the formation of inside oxide scale is uniform; as running hour of plant increases the growth of oxide scale is more in a particular direction i.e., along the direction of flue gas interaction with the tube metal wall surface. This is also confirmed from the observation on the cross-sectional of the failed tube shown in Figure 5.

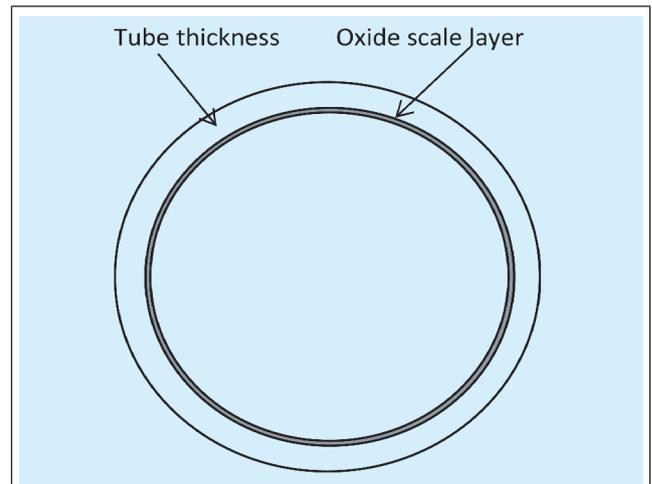
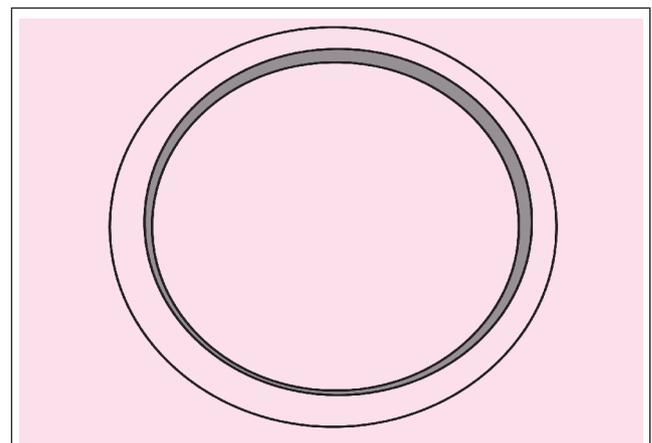
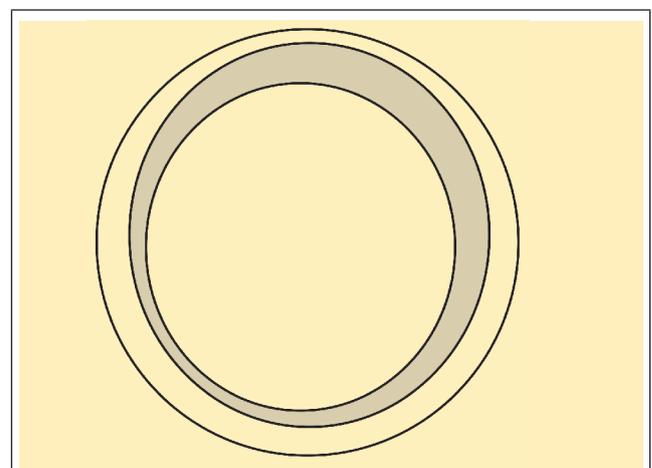
FIG. 6 UNIFORM LAYER OF OXIDE SCALE THICKNESS (AT X RUNNING HOURS OF TUBE/PLANT).

FIG. 7 NON-UNIFORM LAYER OF OXIDE SCALE THICKNESS (Y RUNNING HOURS OF TUBE/PLANT,  $Y > X$ ).

FIG. 8 NON-UNIFORM LAYER OF OXIDE SCALE THICKNESS (Z RUNNING HOURS OF TUBE/PLANT,  $Z > Y$ ).

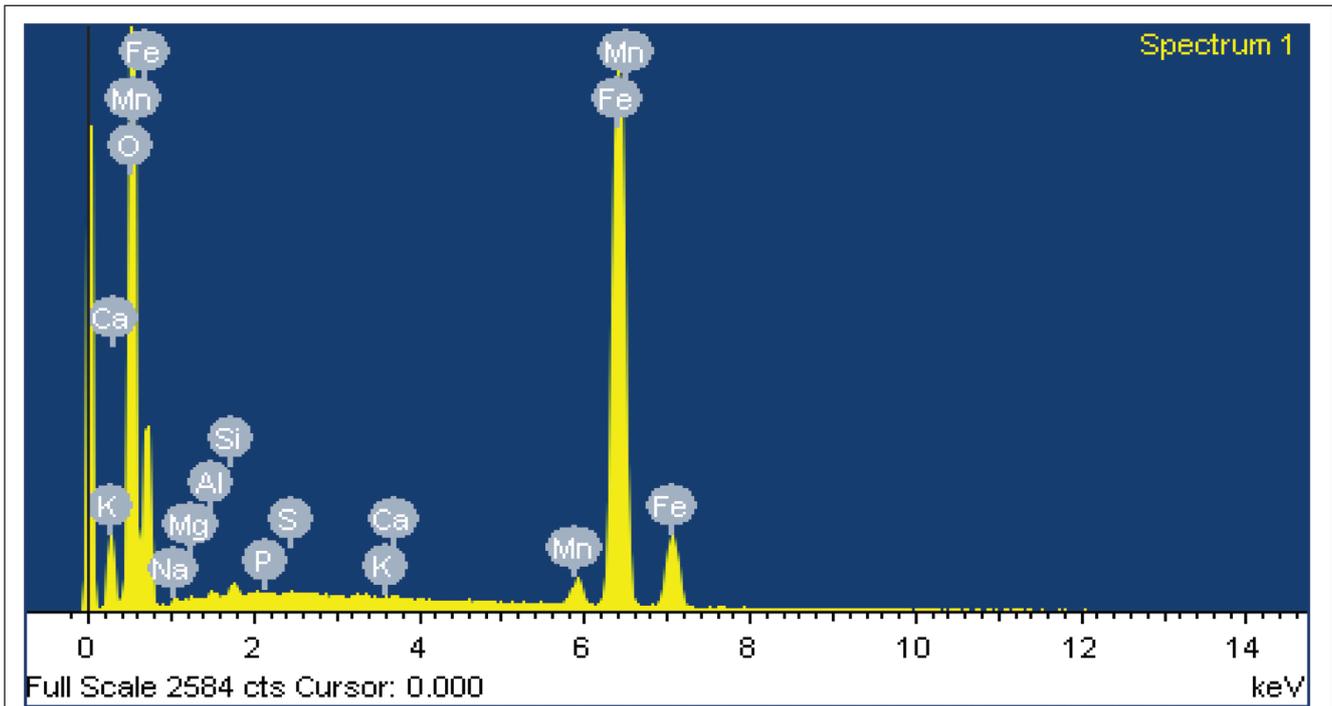
FIG. 9 EDX SPECTRUM OF SCALE FORMED INSIDE SURFACE OF THE FAILED TUBE.

Wt (%)	Na <sub>2</sub> O	MgO	Al <sub>2</sub> O <sub>3</sub>	SiO <sub>2</sub>	P <sub>2</sub> O <sub>5</sub>	SO <sub>3</sub>	K <sub>2</sub> O	CaO	MnO	Fe <sub>3</sub> O <sub>4</sub>	TiO <sub>2</sub>
Inside scale	0.81	0.65	0.48	0.92	0	0	0	0.32	2.15	94.40	-
Outside scale	1.61	0.94	20.66	30.46	0	0.23	0.87	0.72	0	42.71	1.23

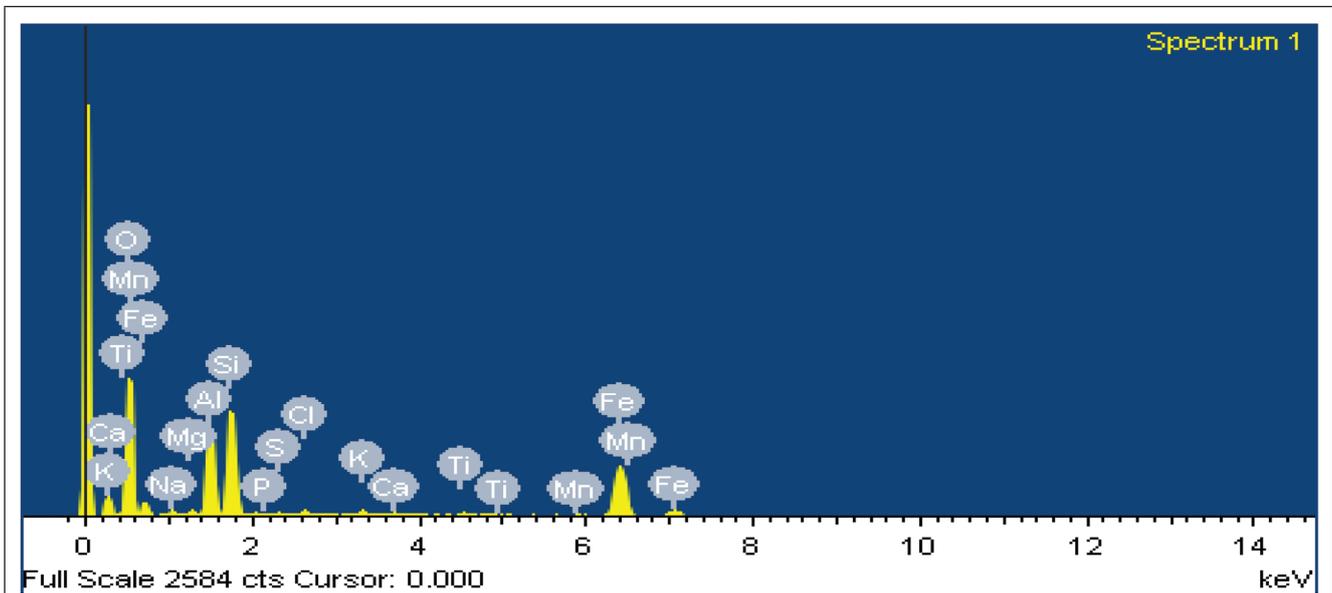
FIG. 10 EDX SPECTRUM OF SCALE FORMED OUTSIDE SURFACE OF THE FAILED TUBE

The received failed tube has also undergone thinning as a result of fire side corrosion, which is in turn due to high temperature and attack of fly ash particle. The EDX analysis of fireside scale confirms the presence of higher percentage of silicon, aluminium, sodium, potassium and titanium, which are the source from the fly ash.

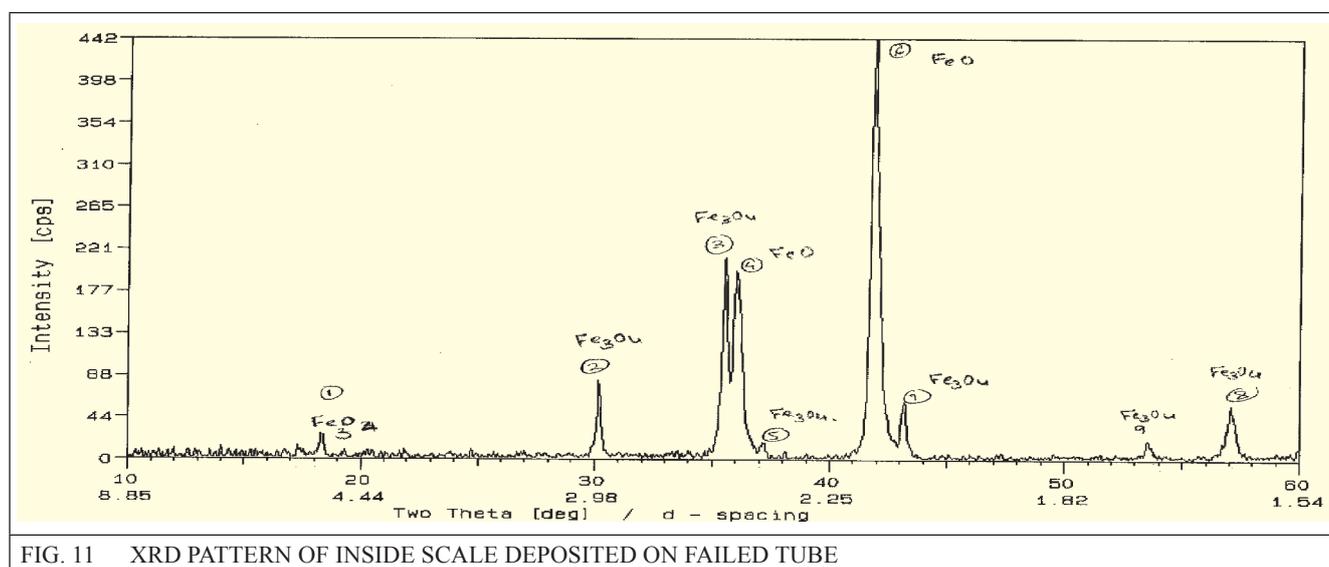
FIG. 11 XRD PATTERN OF INSIDE SCALE DEPOSITED ON FAILED TUBE

The XRD pattern confirms that oxide scale on the inner surface of the reheater tube consists of only Fe<sub>3</sub>O<sub>4</sub> and FeO, which is also confirmed by literature and that at temperature above 560 °C an additional layer of wustite (FeO) may be formed by internal reaction between Fe<sub>3</sub>O<sub>4</sub> and Fe.
