Field Coating of 765kV Transformer Bushings with RTV HVIC: Planning, Implementation and Results

Abstract

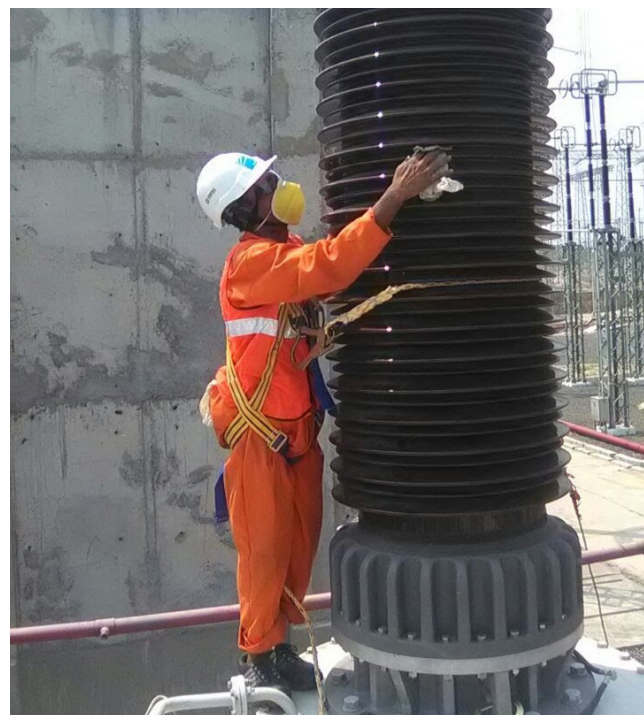
Figure 1. In-situ cleaning of the bushing.

Insulators were cleaned and prepared for coating based on a proprietary sequenced procedure that entailed use of special permitted solvents and water.

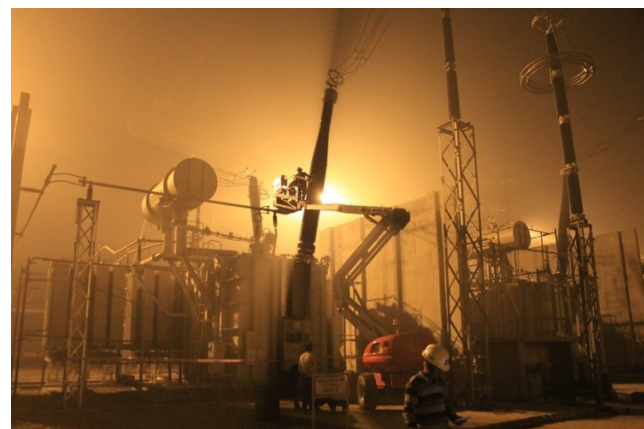
Figure 2. Coating of the bushings.

Coating of erected bushings required man-lift access and shutdowns as work at 765kV cannot be done online – and moreover, live line coating work can only be done using special grade solvents that are nonflammable.

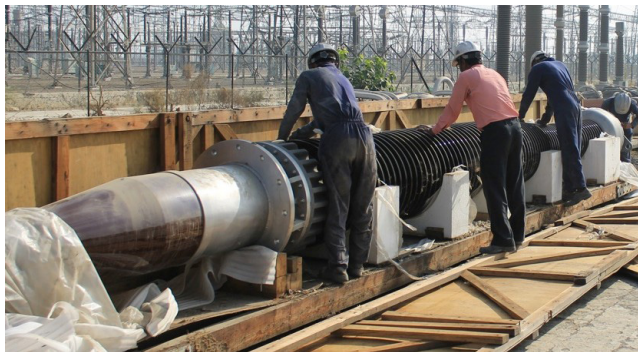
Figure 3. Unpacking the bushing.

Specific procedures for coating bushings in spare were designed. It was planned that two cranes/hydras would be operating, and both the crane controllers should coordinate with each other during the operation.

Rope slings by means of shackles were fitted into the holes provided in the lifting lugs on the metal flanges. Slings of suitable mechanical strength were attached to a spreader; when in horizontal position, the spreader should be at least 60 cm above the top of the bushing.

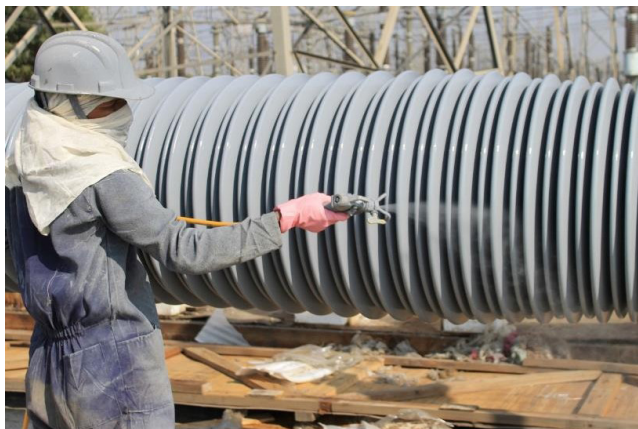
Figure 4. Bushing being coated.

The unpacked bushings were then coated and upon drying, repacked using special padding materials to ensure scratches would be minimized – even though such minor scratches nicks and cuts pose no performance risks to the coating.

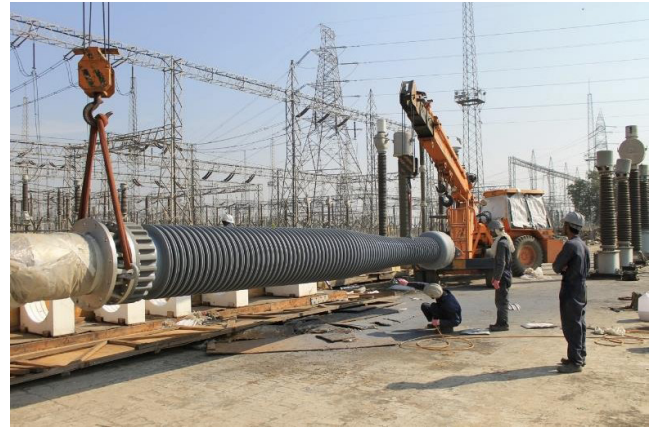
Figure 5. Handling coated bushing.

While bushings were repacked, it was mandatory to follow procedure which required the Oil Gauge to be on the underside of the bushing during storage and handling.

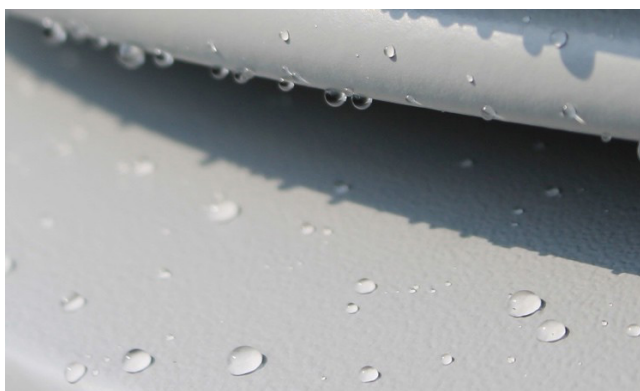
Figure 6. Retained hydrophobicity of Epsilon RTV.

Of the 334 bushings coated with Epsilon brand RTV Coating no flashovers were reported and the hydrophobicity observed (albeit, from a distance) appears to be satisfactory.

Hydrophobicity is a key performance indicator of an RTV coating. A loss of hydrophobicity along a significant and substantial section of the full creepage path of a coated insulator could result in flashover, though this is extremely rare with a good RTV coating and usually only achievable in laboratory conditions.
