End-of-Life Evaluation of RTV Coated Porcelain and Glass Insulators Under Pollution Conditions

Shaik Abdul Saleem*, J Amarnath*, K A Aravind** and D Devendranath***

Ageing of Room Temperature Vulcanising (RTV) silicone rubber coated porcelain and glass disc insulators are reported under combined voltage stress and salt-fog conditions till the loss of hydrophobic properties of RTV coating in an ageing chamber. The electrical characteristics are obtained by online monitoring of leakage current and material characteristics are analysed by Energy Dispersive X-Ray (EDX) analysis. RTV coated glass insulators shattered into pieces after 2600 hours of ageing while RTV coated porcelain after ageing for 4600 hours lost its hydrophobic properties and started behaving like a normal un-coated porcelain disc insulator.

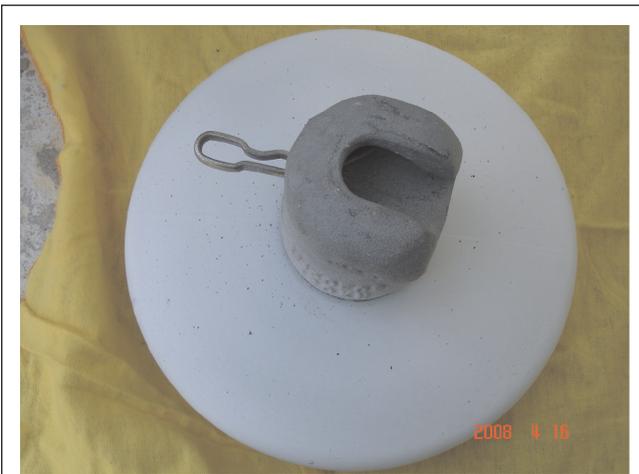
FIG. 2 RTV COATED PORCELAIN (CAP VIEW) DISC INSULATOR BEFORE AGEING TEST

RTV coated porcelain and glass disc insulators and one porcelain disc insulator without coating are subjected to the accelerated ageing test in an ageing chamber under the combined stress of voltage and salt-fog. The porcelain disc insulator was used as a reference sample. The test voltage is 10 kV RMS, flow rate of salt-water is $250 \text{ ml} \pm 10 \text{ ml}$ and salt-fog salinity equal to 0.15 kg/m^3 . The test voltage applied is 40% more than the normal operating phase to ground voltage of an 11 kV system. Higher voltage is used to accelerate the ageing of the RTV coating in the test chamber. The parameters monitored are leakage current, cumulative charge, peak leakage, current pulses, etc., using PXI (Peripheral Component Interconnect Extensions for Instruments Specification) controller based data acquisition system explained in 3.2. Intermittently, RTV coating peeled off and it was subjected to EDX (Energy Dispersion X-ray) analysis. The photographs of RTV coated porcelain and glass insulators at the beginning of the test are shown in Figs. 2 and 3.

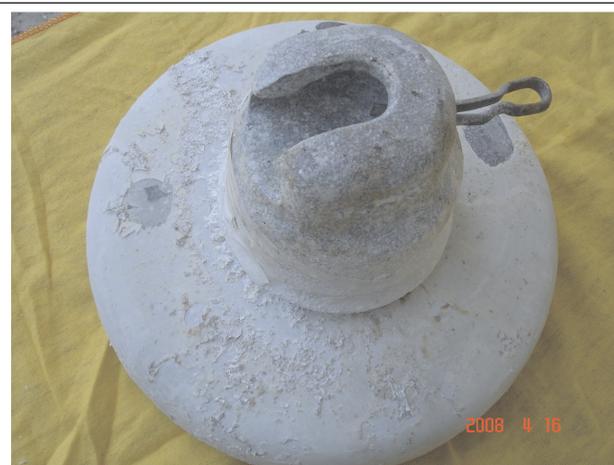
FIG. 5 RTV COATED PORCELAIN DISC INSULATOR AT THE END OF 4600 HOURS OF AGEING TEST

thermal runaway caused by the continuous discharges at the pin end of the insulator. The ageing test on the RTV coated porcelain disc insulator was continued up to 4600 hours. The porcelain disc insulator without coating was removed after 2600 hours of ageing. The photograph of the RTV coated porcelain insulator at the end of 4600 hours of ageing is shown in Fig. 5. The photograph of pieces of a shattered RTV coated glass insulator is shown in Fig. 6. It is seen that the RTV coating on the porcelain disc insulator is almost eroded due to continuous arcing.

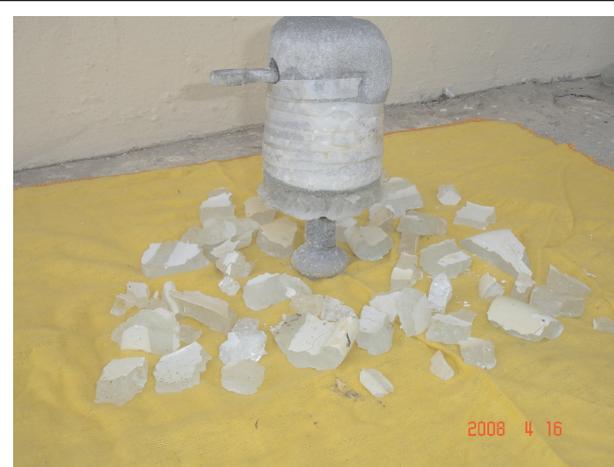
FIG. 6 RTV COATED GLASS DISC INSULATOR (SHATTERED PIECES) AT THE END OF 2600 HOURS OF AGEING TEST

The RTV coated glass insulator shattered at the end of 2600 hours of ageing. Shattering of the glass insulator under pollution is due to the electro-
