Failure analysis of high strength T91 boiler tubes used in thermal power plant: A case study

Arvind Kumar*, Malabika Roy*, Janardhana M* and Shekhar Kumar M*

A power generating utility of 600 MW has reported the failure of boiler tubes after a service life of 265 hours against the design life of 25-30 years. The failure of tubes was reported in Re-heater Inlet Coil tubes which were made up of high strength material alloy of SA 213 T91 grade. These boiler tubes were operating under a high temperature and pressure. The material used for re-heater and super-heater boiler tubes should have enough creep strength to sustain at high temperature and pressure. Even though T91 grade steel has superior quality of metallurgical properties in comparison to low alloy existing material like T11, T12 and T22, T91 tube was failed in a short duration. This paper describes the investigation of the failure of high strength T91 grade re-heater tubes in a coal fired thermal power plant. The failure investigation covers visual inspection, dimensional measurement, hardness mapping, oxide scale measurement, microstructural studies, and SEM and EDX analysis of the failed tubes. The analysis reveals that T

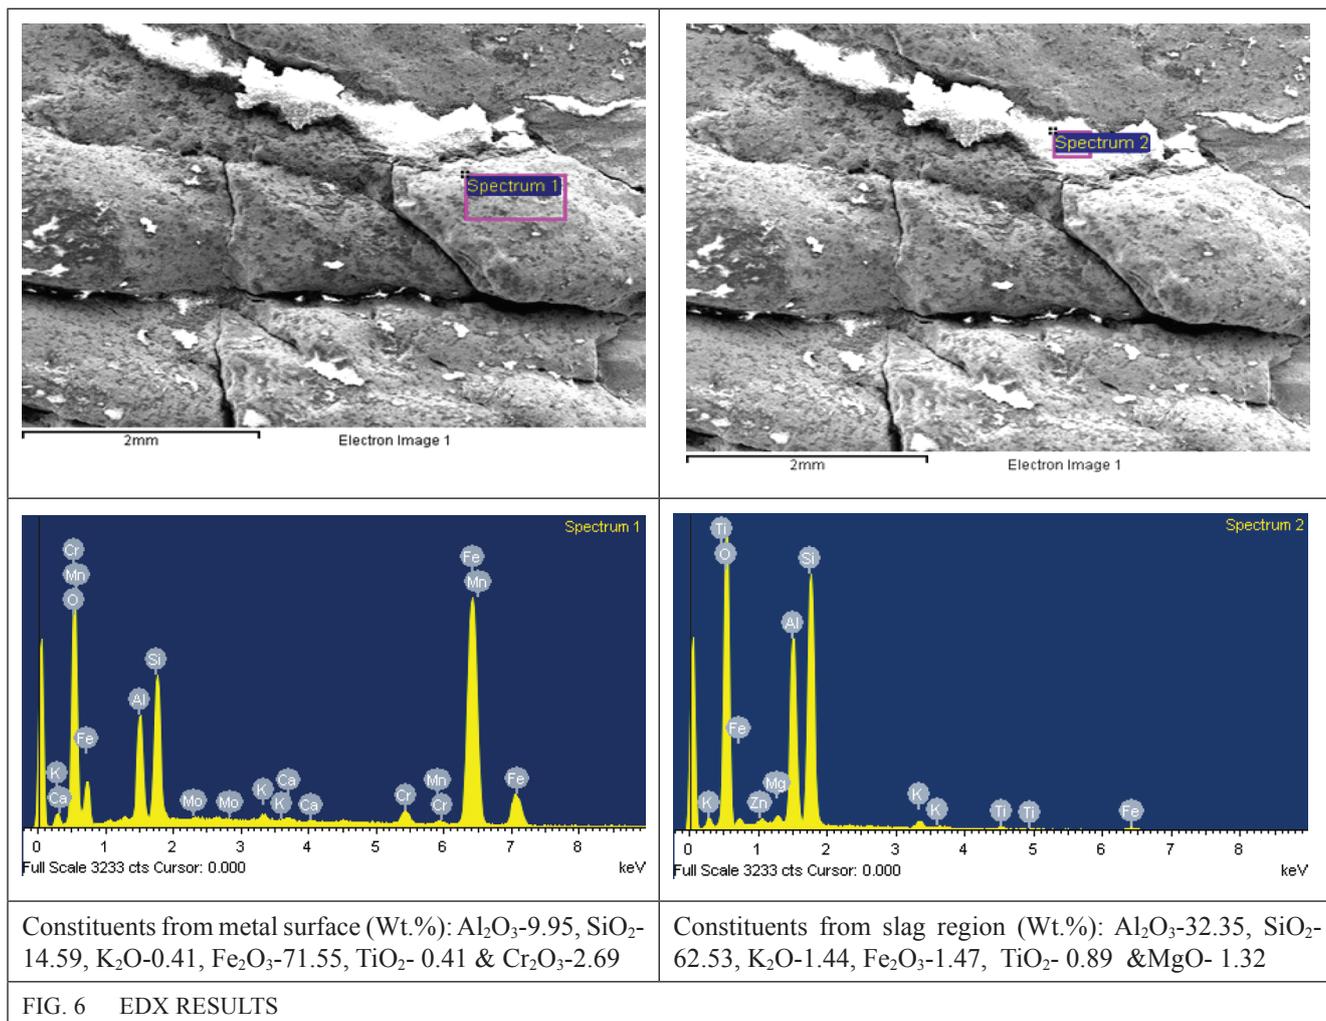
FIG. 5 SEM PHOTOGRAPH

The SEM photograph in Figure 5 shows the many crack lines and the fly ash particles on the tube metal surface and in between the stretched lines. The SEM photograph shows the material has got little ductile failure before opening indicating the high temperature effect for short time of period. The same sample was analysed through EDX and the results are shown in Figure 6. The spectrum taken from the metal surface shows more percentage of iron oxide (more than 70%) and less alumina and silica while the spectrum taken from the slag region shows more percentage of alumina and silica (around 95%) and no iron oxide in the case of flue dust particle.

<p>Sample taken from stretch marked region showing crack lines with fly ash particles.</p>	<p>Sample taken from tip of fish mouth opening showing less ductility</p>

increasing percentage of carbides indicates that the tube has experienced overheating for a short period of time. The SEM results of the fracture surface shows many cracks line in the region of stretch marks, the fractograph surface show little ductility in nature. The less ductility observed on the fracture surface indicates for overheating for shorter time of period.
