Failure of Short - Circuit Generators: A Case Study by CPRI, Bhopal

Arun Kumar Datta*, Ansari M A*, Mondal N R* and Raghavaiah B V*

Year 2006–2007 was a test time for CPRI, Bhopal, when both the short-circuit generators have developed technical snag, resulting in an interruption of short-circuit testing. It was a challenge for CPRI as well as for the service provider to take repair work, as so many technical intricacies were involved including the reverse engineering process. Nation realized the importance of CPRI during the shutdown period. This paper discusses about the occurrence of failure, its detailed diagnosis, root cause analysis and the action taken thereafter. Short-circuit generator is different from conventional one in many aspects. Repairing experiences of these generators, along with the re-commissioning process, are also shared herewith.

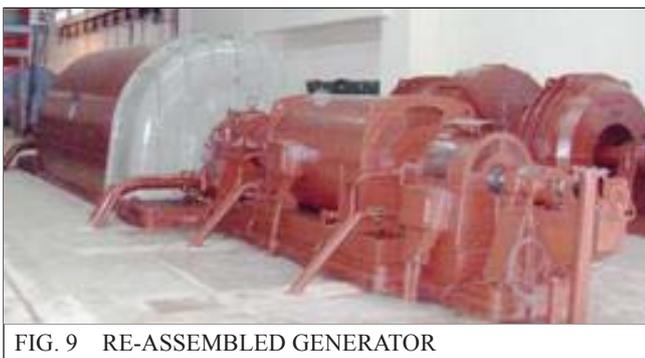
The re-wounded rotor was threaded inside the stator bore and all the required pre-commissioning tests were carried out after the alignment of shaft line (Figure 9). Generator was commissioned successfully.

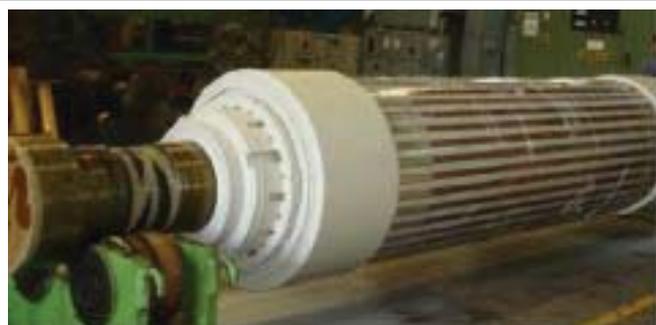
- After assembling all pressing tools, rotor coil insulation polymerization cycle was performed at 100°C.
- Over speed at 10 % above nominal speed was carried for two minutes [3].
- Rotor was balanced at 3000 rpm and vibration values were NDE: 7.067 microns (pk-pk) and DE: 5.115 microns (pk-pk).
- During balancing, RSO test was performed (Figure 13) in running condition at nominal speed.
- IR value, winding resistance and high-voltage test results are tabulated below (Table 7).
